# REPORT ASSESSING INNOVATIVE RESTORATION TECHNIQUES, TECHNOLOGIES AND MATERIALS USED IN CONSERVATION

Deliverable D. T1.3.1

04/2018

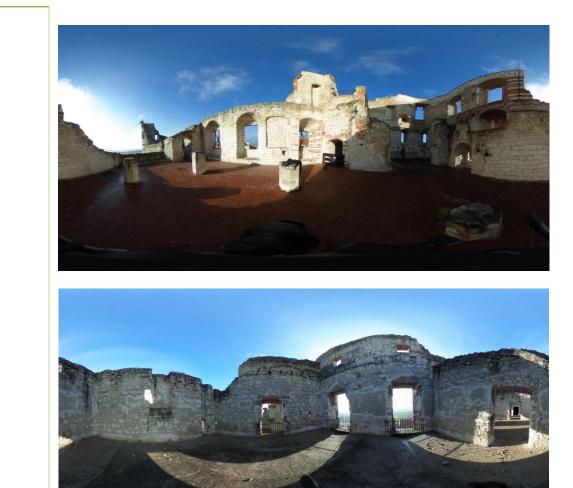
Method	360-degree photography
Kind	Recording
Basic description	Camera for taking detailed 360-degree photos and videos
Specification	Name: Ricoh THETA V Video footage resolution: 4K (3840 x 1920), 2K (1920 x 960) - 30 fps Photo footage resolution: 5376 × 2688 px Internal memory: 19 GB Weight: 0.121 kg Extra features: BT, USB, Wi-Fi
Range of use	Taking photographs of buildings, structures, and interiors. The device can take full 360-degree photographs.
Intervention rate	Non-invasive
Main advantages	Spherical, 360-degree footage
Negatives or risks	Its use depends on weather conditions (see device specification)
References	
Available at	Lublin University of Technology
Keywords	360-degree camera, spherical camera, pictures, photographs, footage
Recording author	Bartosz Szostak, Lublin University of Technology
Images	RICOH

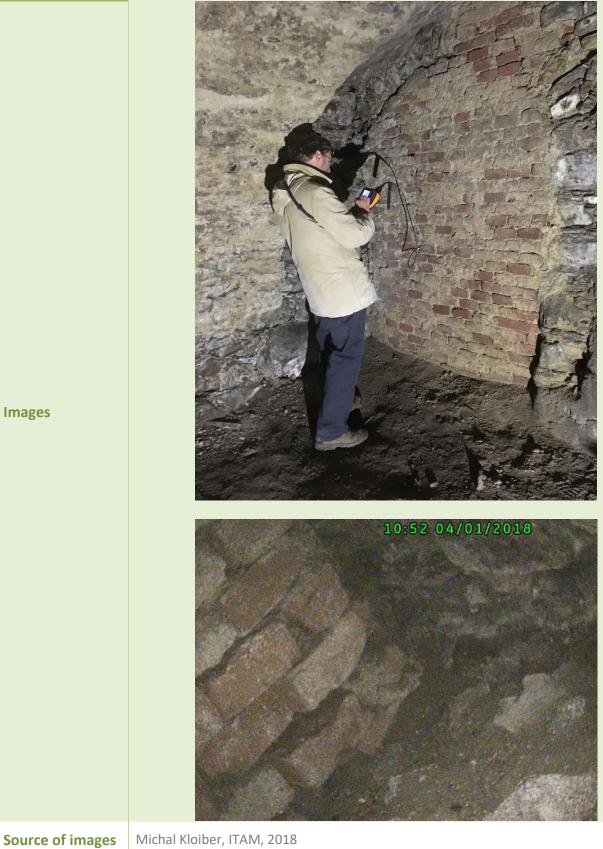
Site Specification	Zámek Telč (Telč Chateau)			
Localization	Telč –Inner Town Nr. 1, Vysočina Region, Czech Republic			
Owner and management	National Heritage Institute			
Affected part	Beer cellar in former brewery			
Intervention reasons	Archaeological: exploring of hidden underground spaces			
Intervention extent	A hole Ø 20 mm in a mortar gap of the masonry joint			
Date of intervention	2018-01-29			
Time consumption	1 hour			
Results	Finding a corridor leading to a stone door frame of late medieval origin			
Evaluation	The complementary arguments for further decisions regarding a possible displacement of the recent separating wall have been acquired in a nondestructive way.			
References	Not yet published

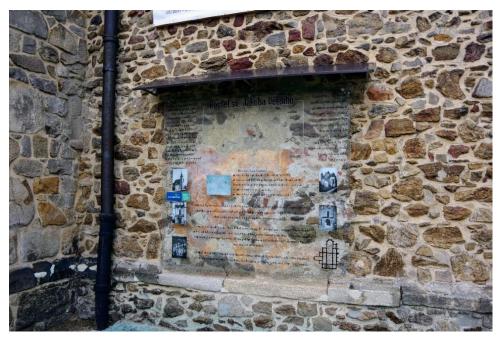
Transparent information board on the wall of the St. James Church in Jihlava (CZ)

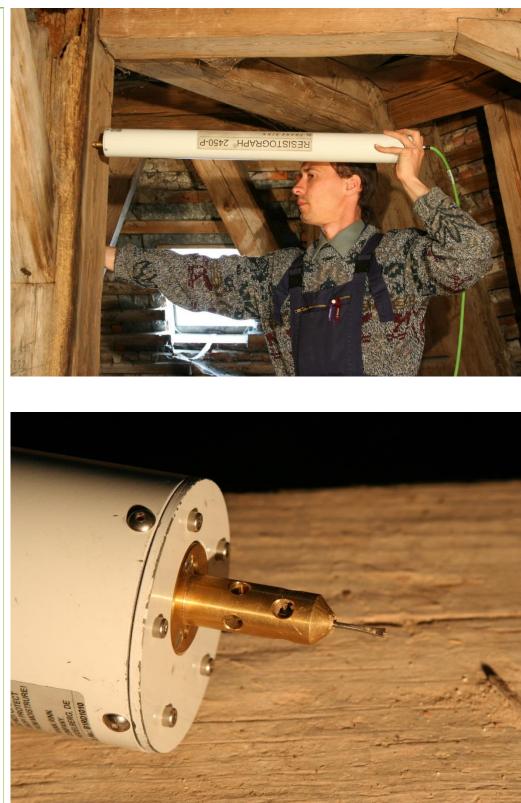
Negatives or risks	The length of the case (cca 60 cm) is sometimes limiting for measurement in desired direction.
References	RINN, F. – SCHWEINGRUBER, F.H. – SCHÄR, E. 1996: RESISTOGRAPH and X-ray density charts of wood comparative evaluation of drill resistance profiles and X-ray density charts of different wood species. Holzforschung 50: (4), 303-311.
Available at	ITAM AS CR
Keywords	Drill resistance, wood
Recording author	Jiří Bláha, CET

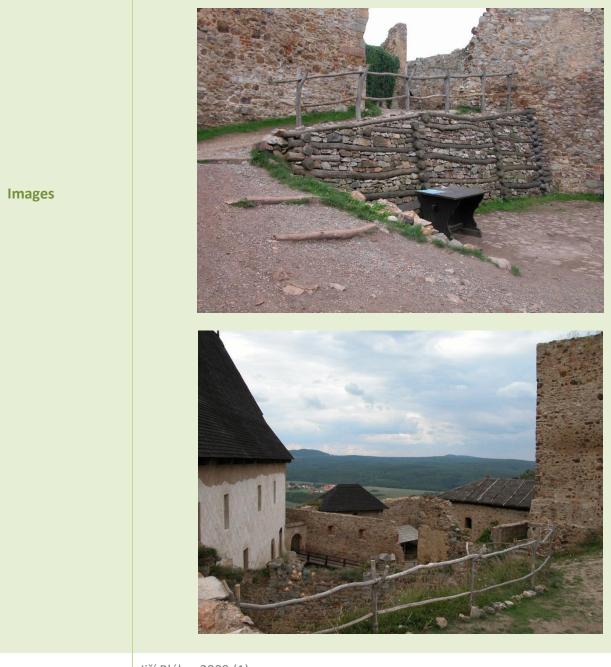
Site Specification	Hrad Točník (Tocnik Castle)
Localization	Točník Nr. 10, Beroun District, Middle Bohemia Region, Czech Republic
Owner and management	Národní památkový ústav (National Heritage Institute)
Affected part	The second castle courtyard. A pathway joining different levels of terrain within the castle ruin.
Intervention reasons	Securing the stability of a steep slope before water erosion in the event of torrential rains.
Intervention extent	Minor changes in path tracing. Reuse of stones spontaneously released from ruined parts in the past.
Date of intervention	About 2005
Time consumption	Not known
Results	The retaining construction combines dry laid stones picked in the ruin grounds with local oak tree trunks.
Evaluation	A combination of local stone and wood looks naturally and very well fulfills its purpose.
References	
	<image/>

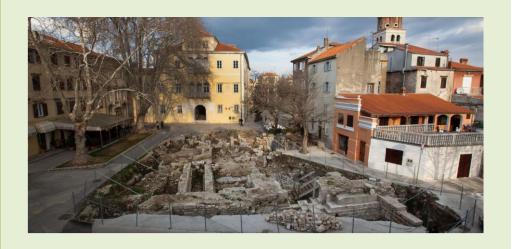
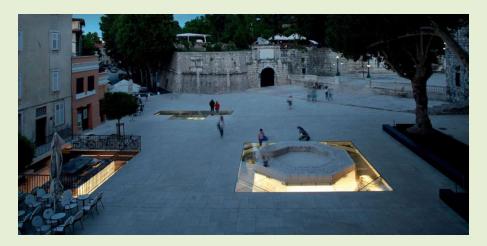
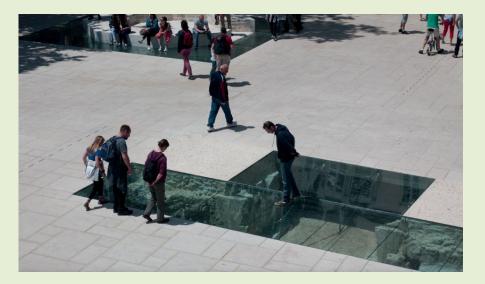
Site Specification	Trg Petra Zoranića (Petar Zoranic Square)
Localization	Zadar, Dalmatia Region, Croatia
Owner and management	City of Zadar
Affected part	The area of the square (2900 m2) paved with limestone slabs.
Intervention reasons	Presentation of a selected part of the foundations of the buildings exposed during the archaeological research of the square compatible with the everyday uses of the square. Making a "glass interface" between the Roman and medieval finds below and the contemporary square above.
Intervention extent	Three spots were chosen to offer a visual contact with archaeological situations. Found base of the octagonal Roman tower was completed up above the level of the terrain and modified for casual sitting.
Date of intervention	2011-2013
Time consumption	Not known
Results	The project was prepared by architects Aleksandra Krebel and Alan Kostrenčić. Three glass sections laid level with the ground are integrated into the architectural design of the square. They are offering views into the past of the city and profiting from the mirroring effect in its present life. They also manifest themselves in night illumination.
