# BEST PRACTICE HANDBOOK – TRANSNATIONAL MODEL OF SUSTAINABLE PROTECTION AND CONSERVATION OF RUINS

D.T1.4.3

TECHNICAL INVESTIGATIONS  
OF HISTORICAL RUINS

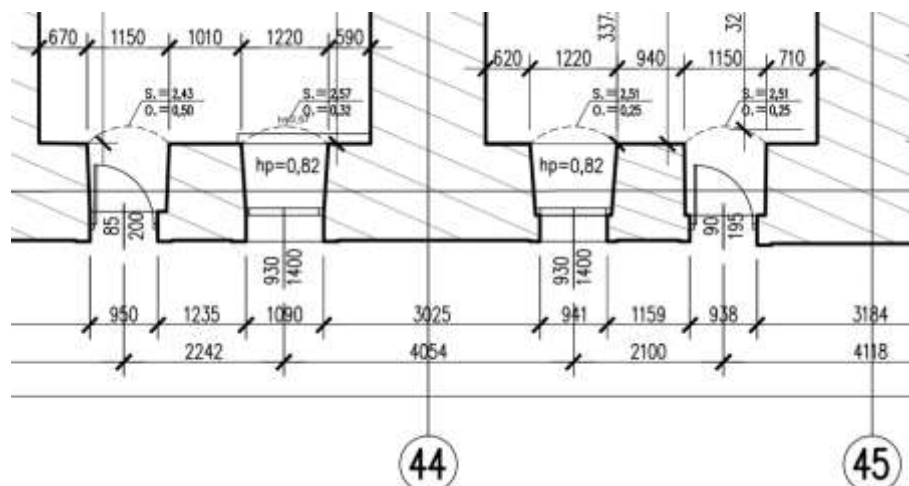
Figure 1 Fragment of the final stocktaking of the Kłodzko Donjon Fortress - a horizontal cross-section of the "0" storey - the stocktaking made using a computer drawing software.

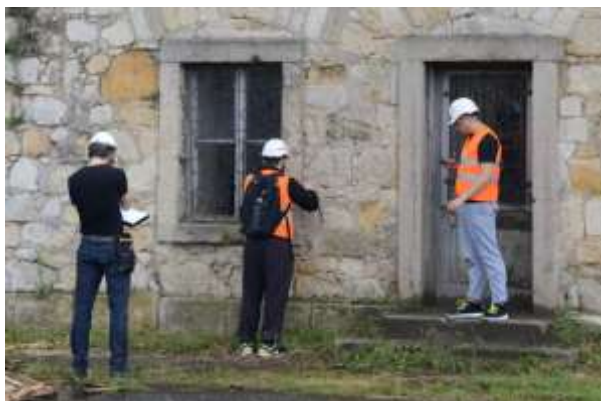
Photo 1 Traditional measurements of the elevation of the Kłodzko Donjon Fortress

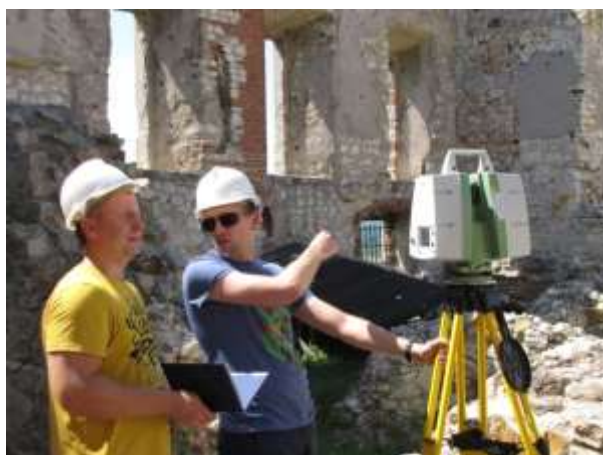
Photo 4 The Leica ScanStation C10 while taking measurements

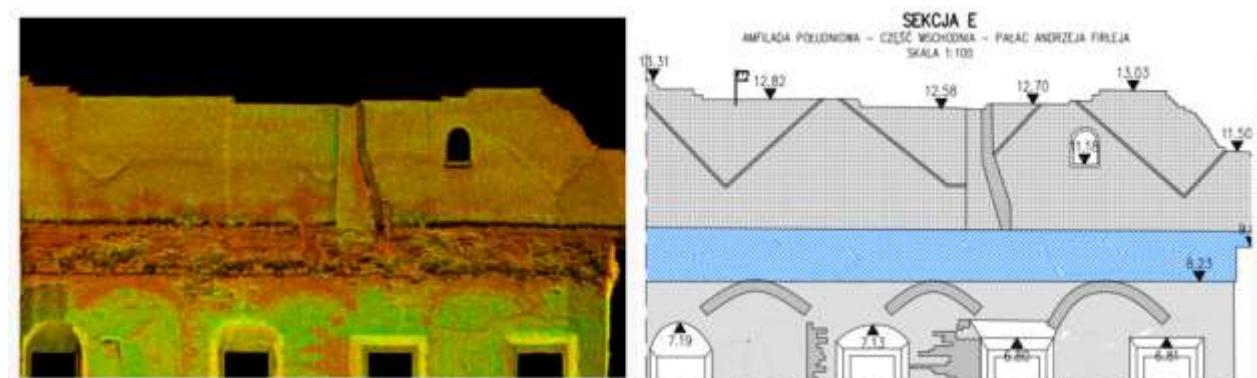
Figure 4 A view of the facade of the Janowiec castle developed on the basis of a 3D scan

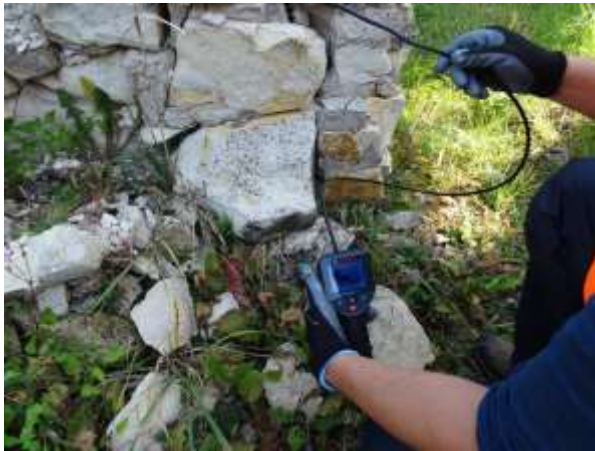
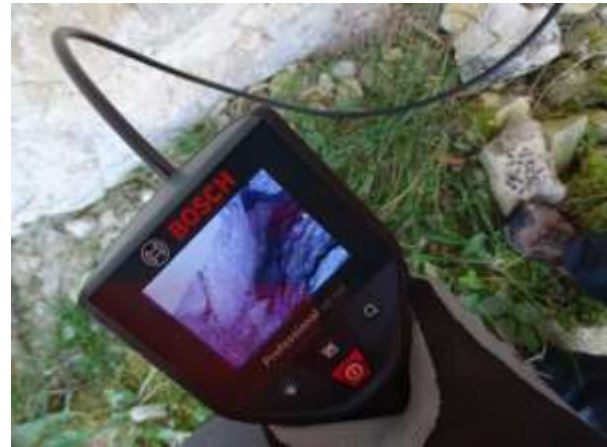
Photo 5 The endoscopic camera

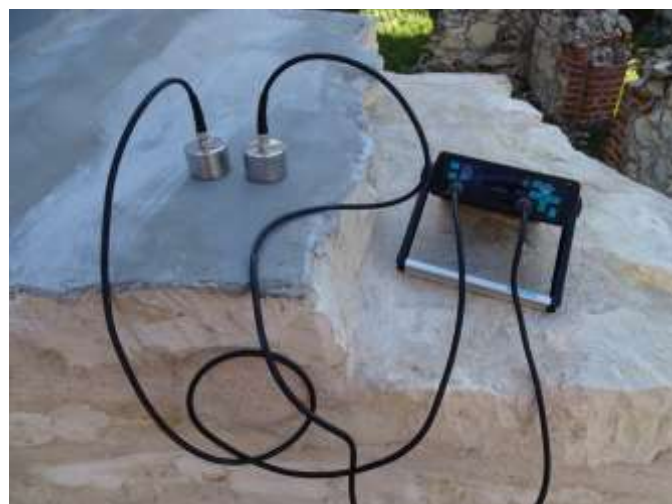
Photo 6 Ultrasonic testing equipment

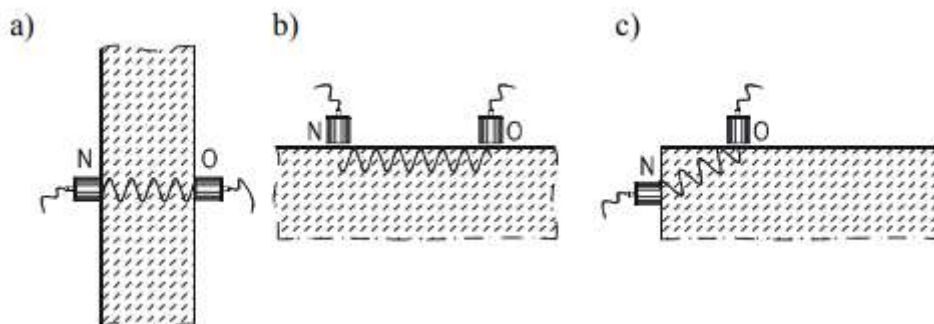
Similarly to the ultrasonic test, the method is based on the phenomenon of propagation of acoustic waves in the elements tested, with the difference that they are excited in a mechanical way. The method of defects detecting is based on the echo method (waves reflected from defects in the material structure are registered and processed).

Figure 5 Scheme of measurements performing and distribution of probes<sup>8</sup>

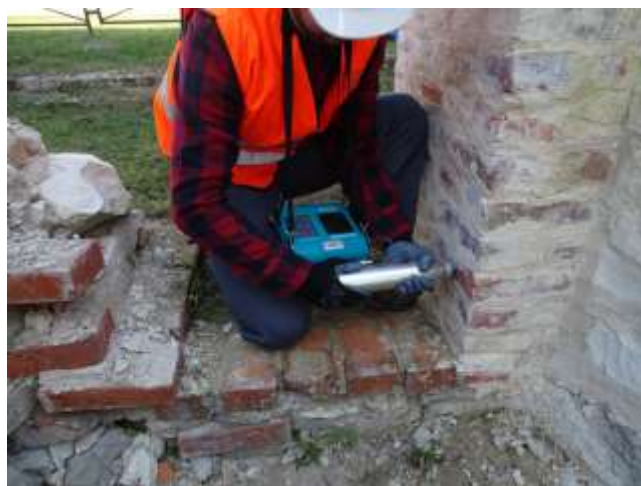
Photo 8 Photo taken during sclerometric test

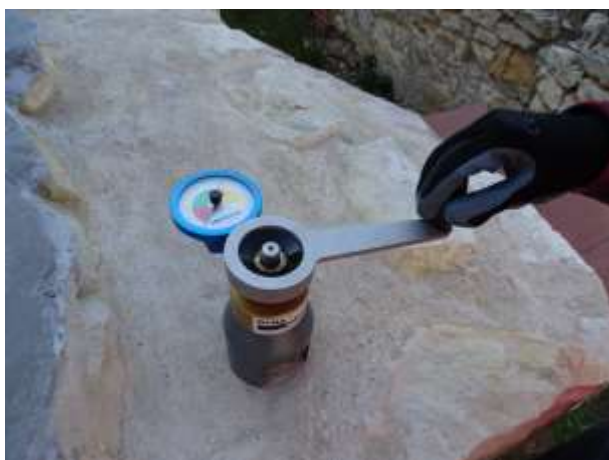
After hardening of the glue on a steel disc in a place designed for it, a steel spindle should be placed. Then, according to the recommendations of the standards, the test should be performed with a force increasing by 10 N, every 1 second. The test is carried out until the sample is detached from the base.

Photo 9 Photo during the test.

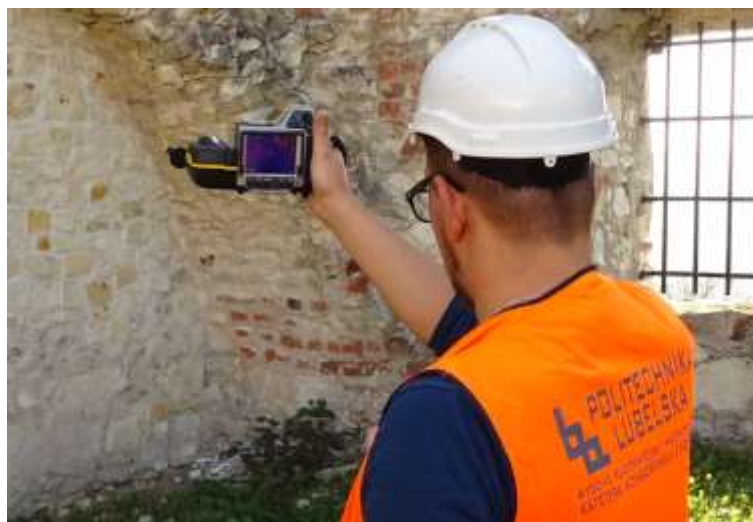
In buildings in ruin, the thermal imaging camera finds its application for recognizing various elements. Due to the phenomenon of thermal accumulation, materials with different densities will obtain different temperatures. There may be a situation, in which the materials have reached a temperature balance with the surrounding and will have the same surface temperature, regardless of their density. Then the test should be extended to the active thermovision. The active thermovision consists in temporarily heating or cooling the examined part of the element. Due to differences in the physical construction of materials, they will heat or cool at different rates. By observing in real time the temperature changes of the fragment examined caused by the external factor of elevated or reduced temperature, it is possible to identify the elements. When performing active thermovision, the influence of the thermal shock on the elements tested should be taken into account. The test temperature should be chosen in such a way as not to damage the object tested.

Photo 11 Thermal camera during test

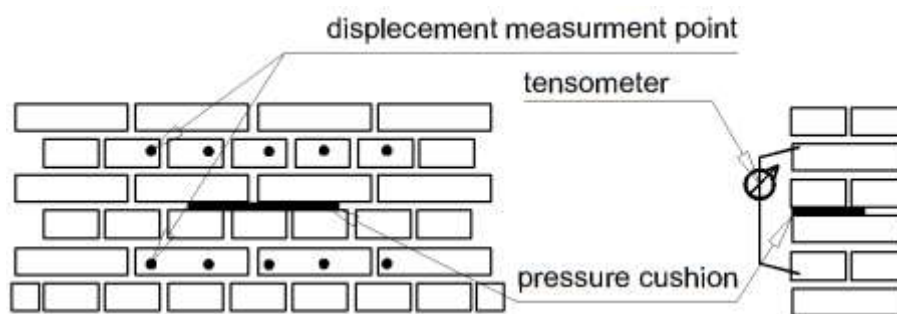
The method of determining stresses in the masonry by means of pressure cushions is very simple. The first step is to properly arrange the control points and measure the distance between them (with an accuracy of 0.001mm). Next, a furrow (by cutting or notching) in which the pressure cushion is placed, should be made between the measuring points. The pressure cushion is made of a metal sheet and its shape depends on the shape of the furrow made. Next, the cushion is filled by a liquid and the stresses caused by filling the cushion and increasing its volume in the masonry are monitored on a current basis using a manometer. Measurements between control points are performed on a regular basis. The value of the manometer must be read when the values of the distance from before the furrow was made are equalized. After proper reduction of the value depending on the shape of the cushion and the pressure surface of this cushion, the value obtained is the value of stresses in the masonry. Based on the analysis of the technical literature, the measurement error was estimated at no more than 33%.

Figure 7 Stress measurement in the masonry with a single pressure cushion

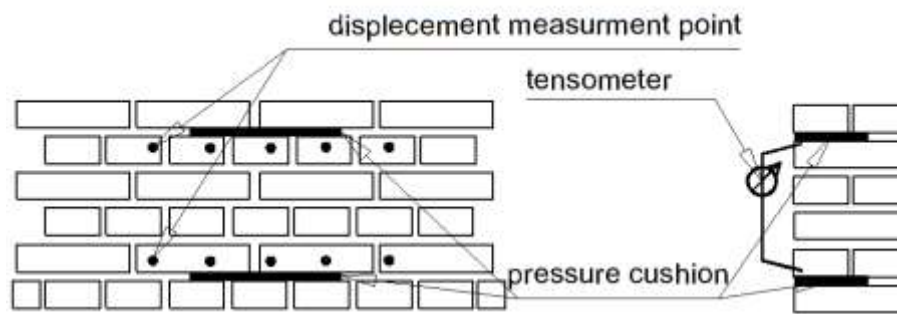
Measuring the deformability of the wall consists in making two furrows and fixing cushions in them. Between the furrows the control points should be marked and distance measurements on them should be taken. Determination of deformability of the wall consists in describing the relationship of stress increase to strain increase (Young's modulus) in the masonry structure.

Figure 8 Measuring the deformability of the wall and possibly its strength by means of two pressure cushions

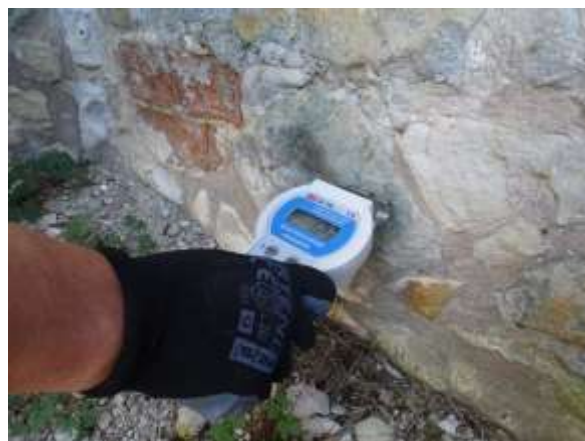
Photo 14 The LB-796 dielectric moisture meter.

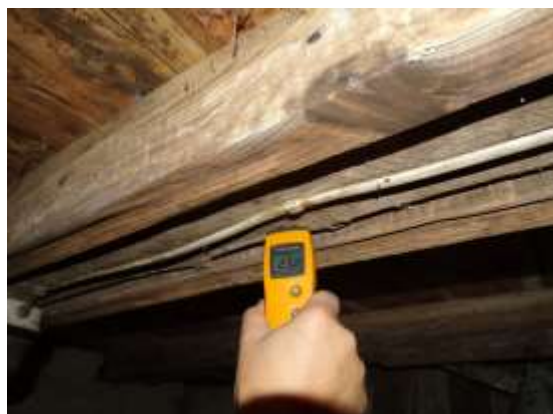
Photo 15 The Protimeter Timbermaster Moisture Meter hygrometer.

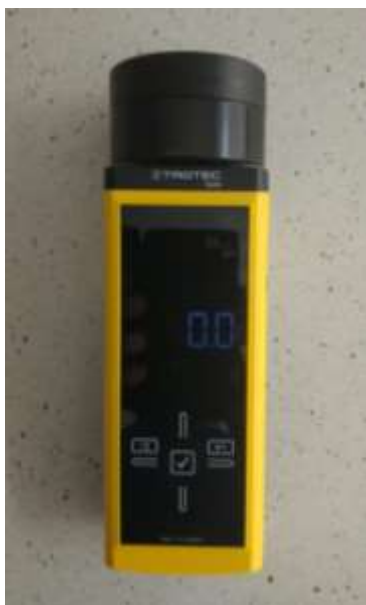
Photo 17 The TROTEC T610 hygrometer

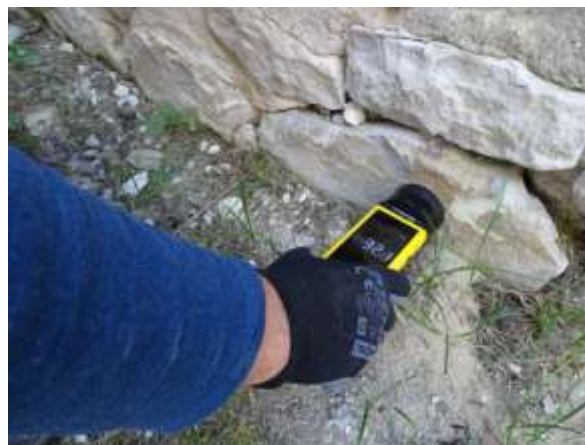
Photo 18 Moisture measurement by the microwave method

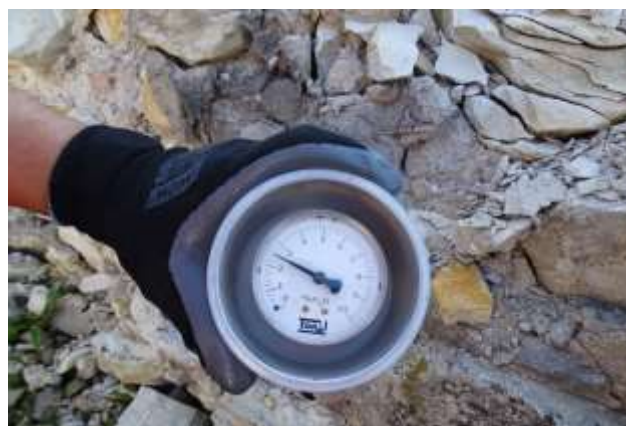
Photo 20 Investigation of moisture by the carbide method, reading of the acetylene pressure in the tank

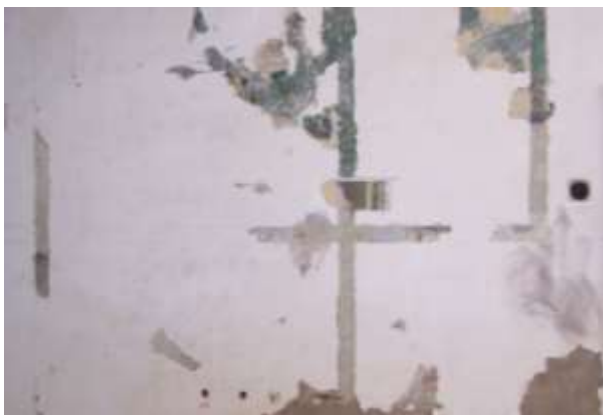
Photo 21 Strip outcrop with probes revealing bottom layers of painting.

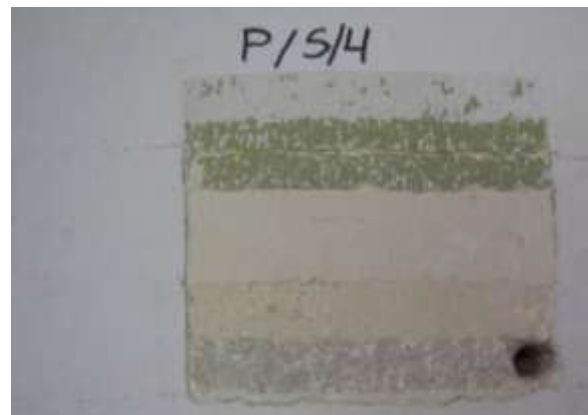
Photo 22 Stepped probe showing the arrangement of layers of plasters and paintings on the wall.

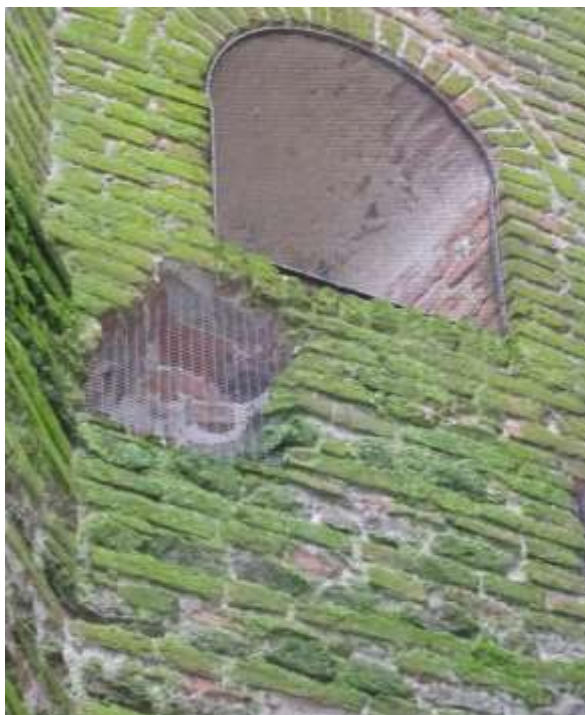
Photo 23 Algae colonies on a moist ceramic brick wall.

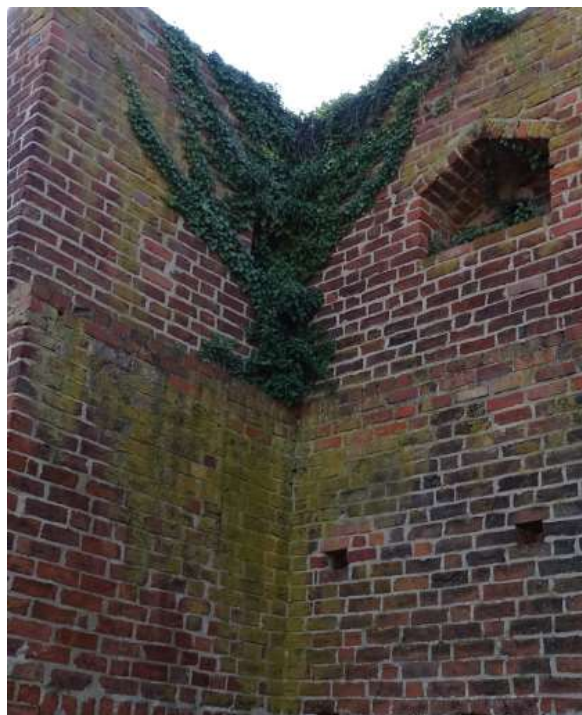
Photo 24 The development of algae and lichen in the corner of the wall directly under the ivy, which is growing the wall and the crown.

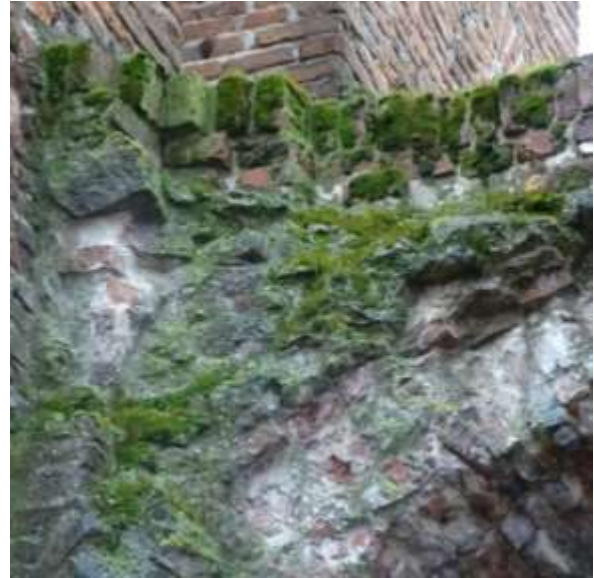
Photo 28 Moss and algae, which overgrow the crown and the face of the wall.

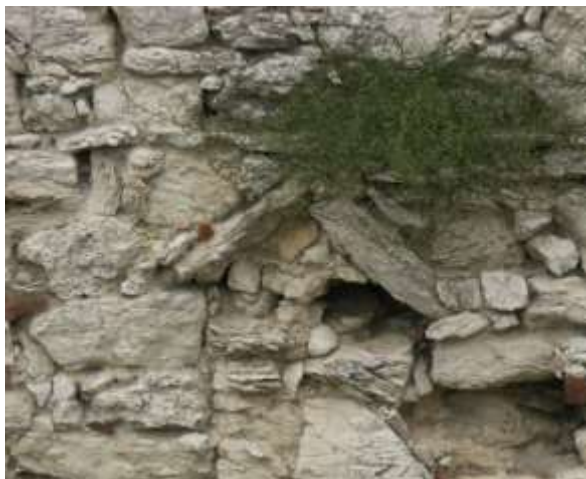
Photo 29 Photograph of a heavily sunlit southern façade. The development of vegetation in the wall crevices.

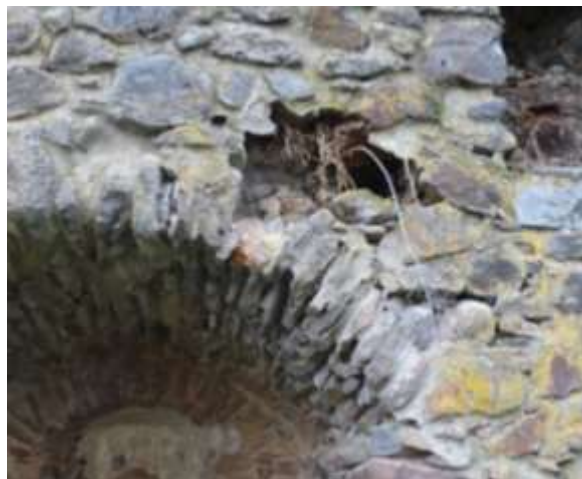
Photo 30 Damage to the face of the wall associated with the growth of the root system of low vegetation.

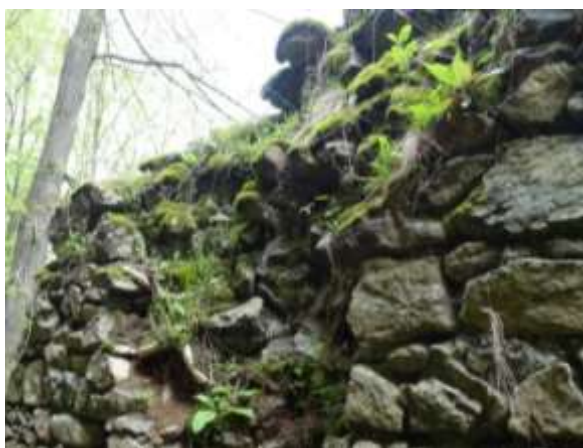
Photo 31 The crown and the face of the curtain wall planted with a single and perennial vegetation.

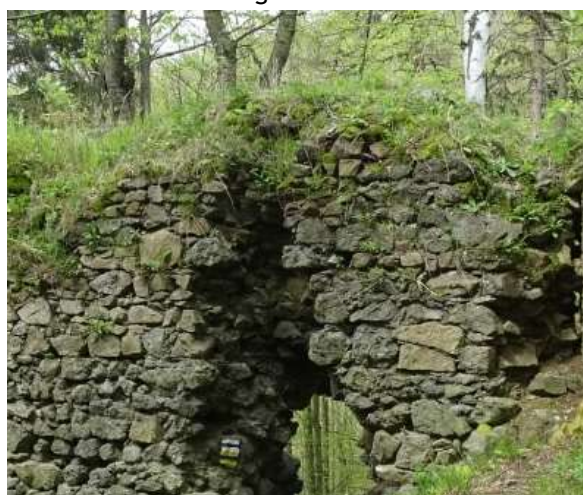
Photo 33 The low crown of the wall completely overgrown with greenery. The tight layer of humus and greenery prevents evaporation of the moisture retained in the wall.

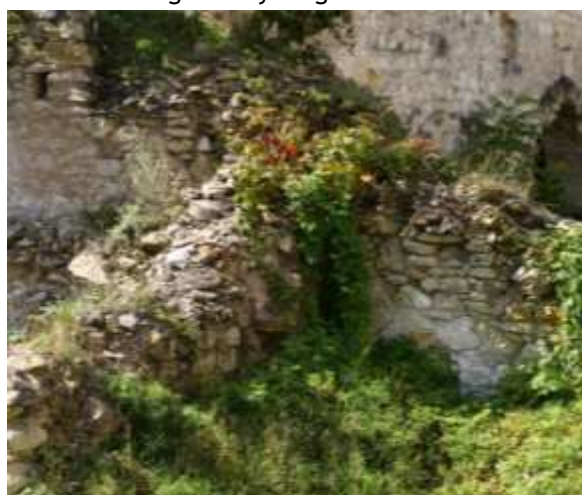
Photo 34 A wall relic covered with vegetation. A large amount of green causes the illegibility of the ruin.

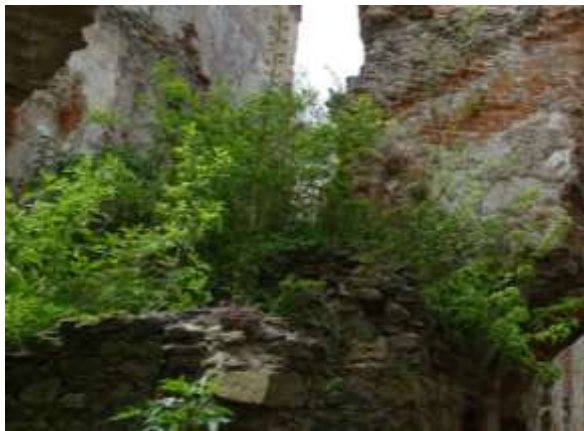
Photo 35 A fragment of the vault intensely overgrown with shrubs.

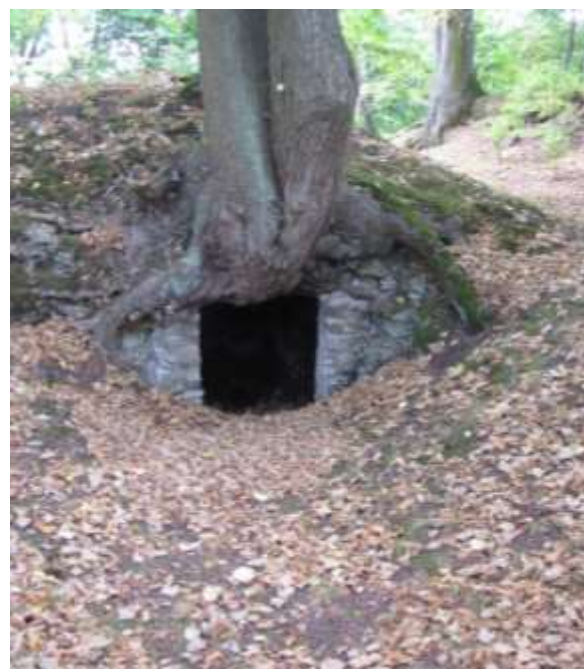
Photo 39 Vault made of ceramic brick damaged by roots.

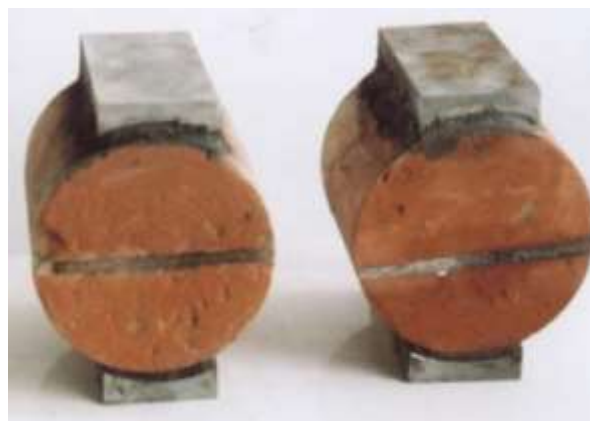
Photo 42 Samples prepared for testing.<sup>19</sup>

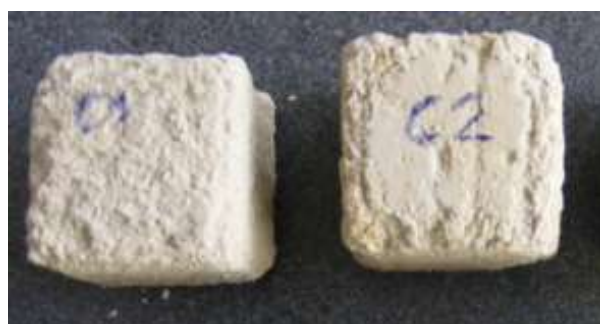
Photo 63 Resistance test for salt crystallization. Limestone rock samples after 2 cycles.

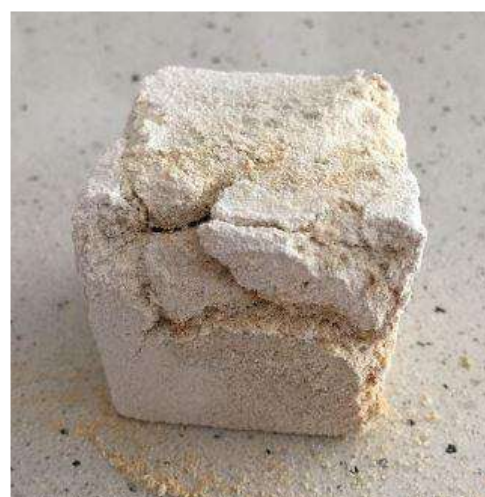
Photo 66 Resistance test for salt crystallization. Sandstone samples after 10 cycles.

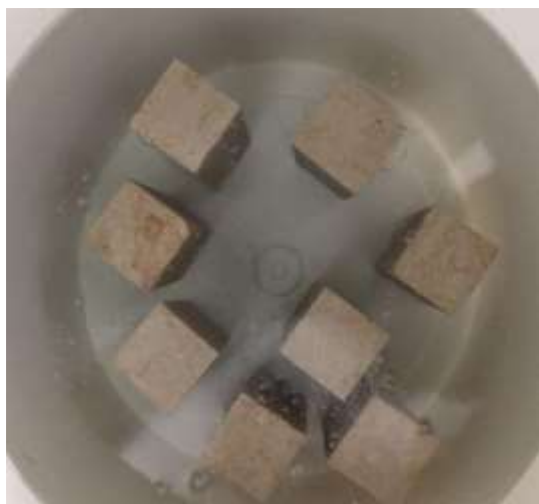
Photo 67 Frost resistance test. Soaking of sandstone samples.

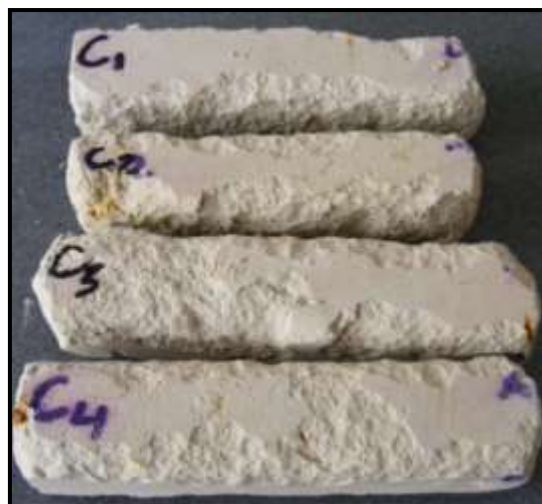
Photo 68 Frost resistance test. Samples from limestone rock after 56 freezing cycles.

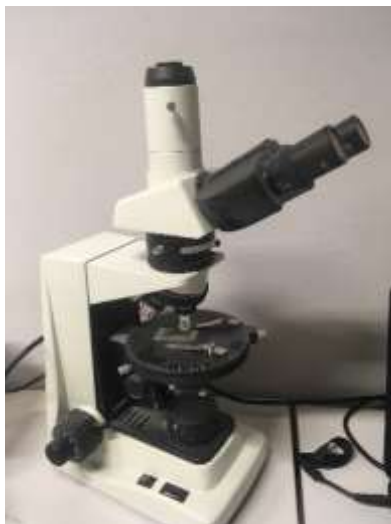
Photo 73 Polarizing microscope - Zeiss Axiolab.  
WBiA laboratory of the Lublin University of Technology

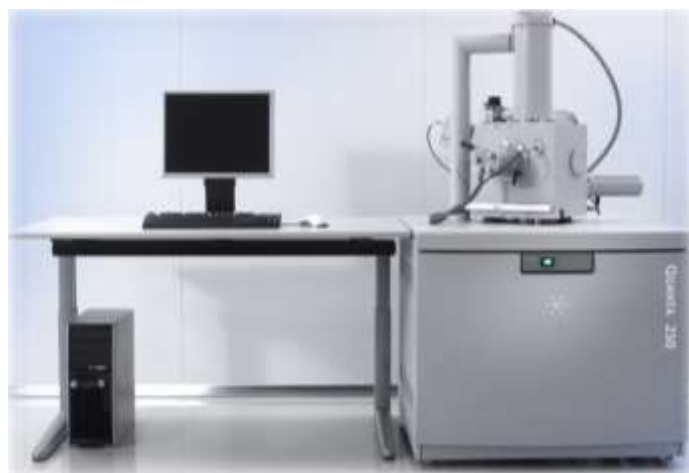
Photo 76 Scanning electron microscope with detector - Quanta 250 FEG by FEI company, EDS detector by EDAX.

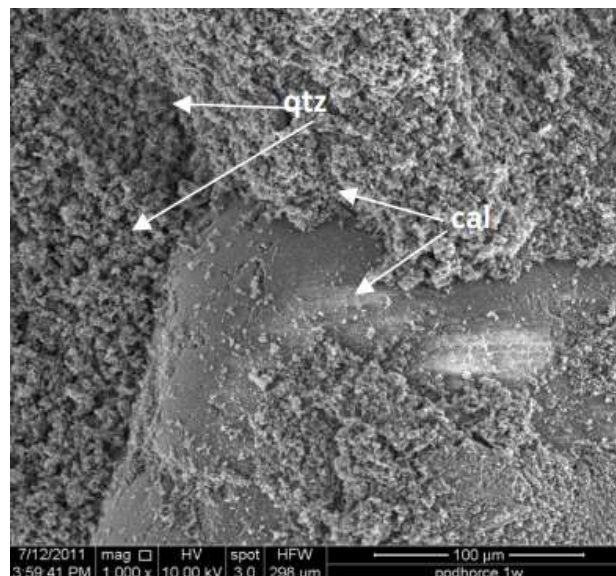
Photo 77 An image of the fracture of a lime mortar sample (SEM 800x) shows a porous compact mass of the lime binder (cal), in which small individual larger quartz grains are visible (qtz).

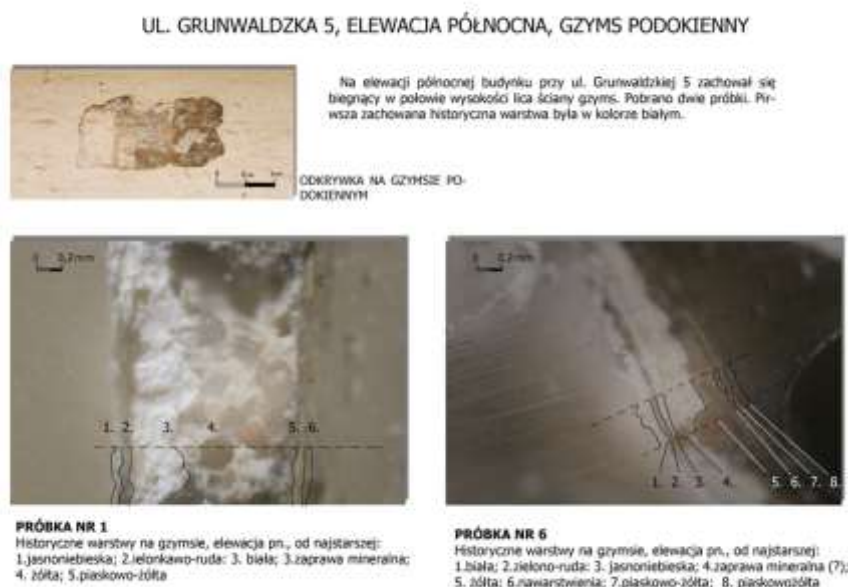
Photo 79 The micrograph of the cross section of the painting layer on the plaster in visible light shows the presence of the following layers: 1 light blue, 2. greenish red, 3. white. 4 mortar, 5. yellow, 6. sandy - yellow.

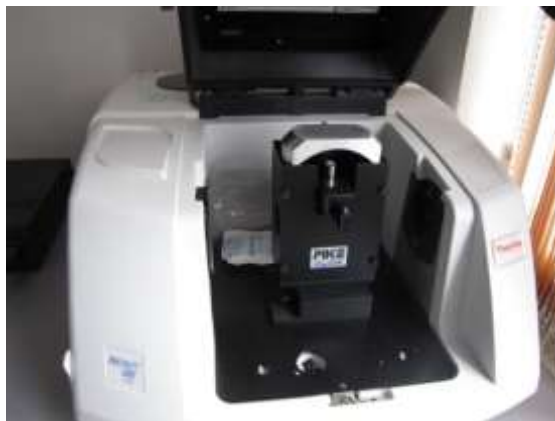
Photo 81 The infrared spectrometer - FTIR Nicolet.  
WBiA laboratory of the Lublin University of Technology

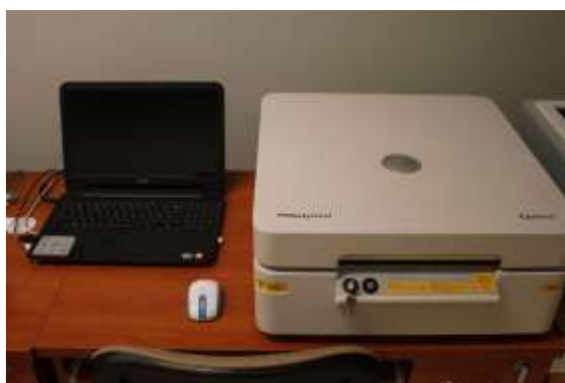
Photo 82 The Epsilon 3 spectrometer by Panalytical.  
WBiA laboratory of the Lublin University of Technology

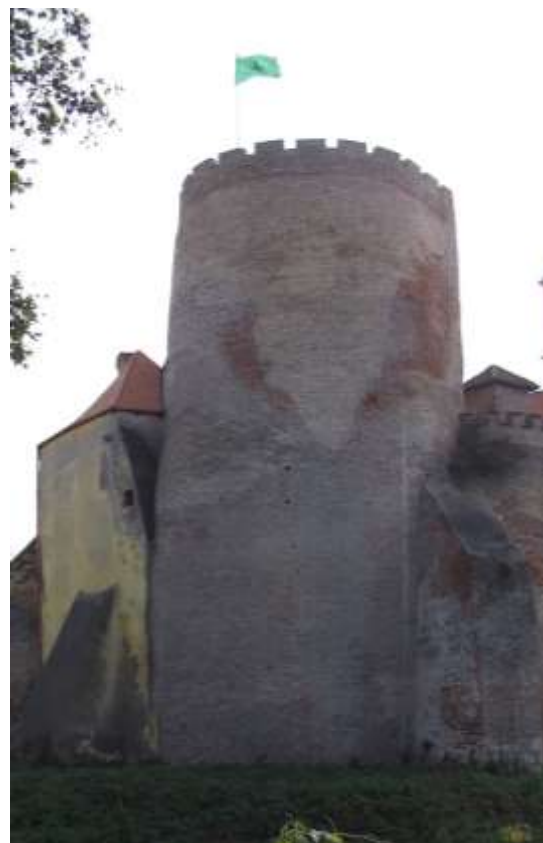
Picture 10. The present state of the tower: the 'stains' on top of the walls of the tower present the restored parts of the tower as well as areas with increased percentage of moisture in the walls.

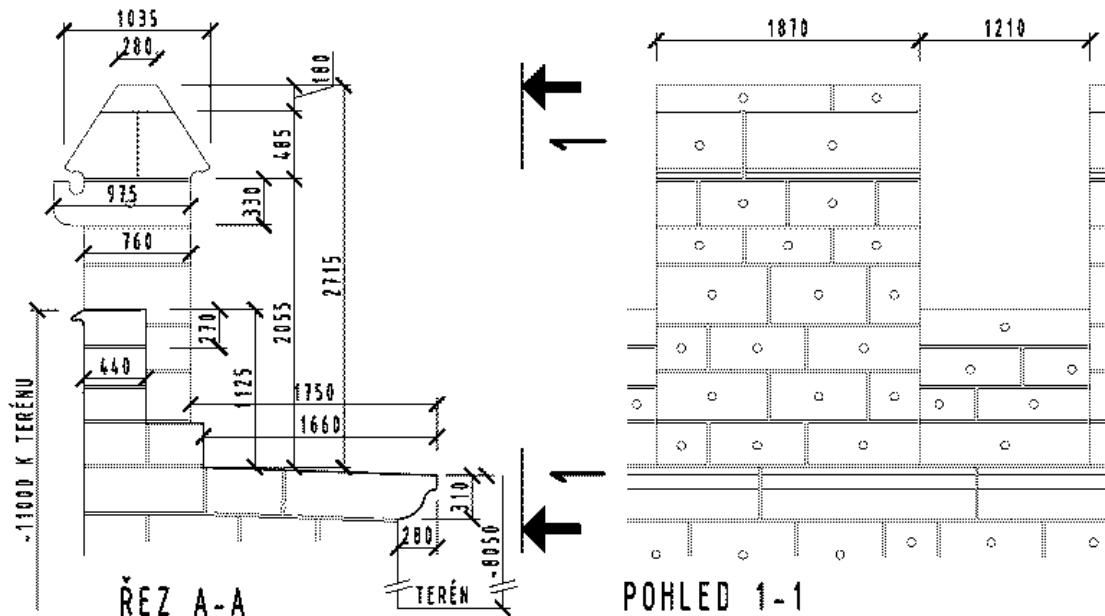
*A section and front view of the parapet wall situated on the eastern side of the castle*

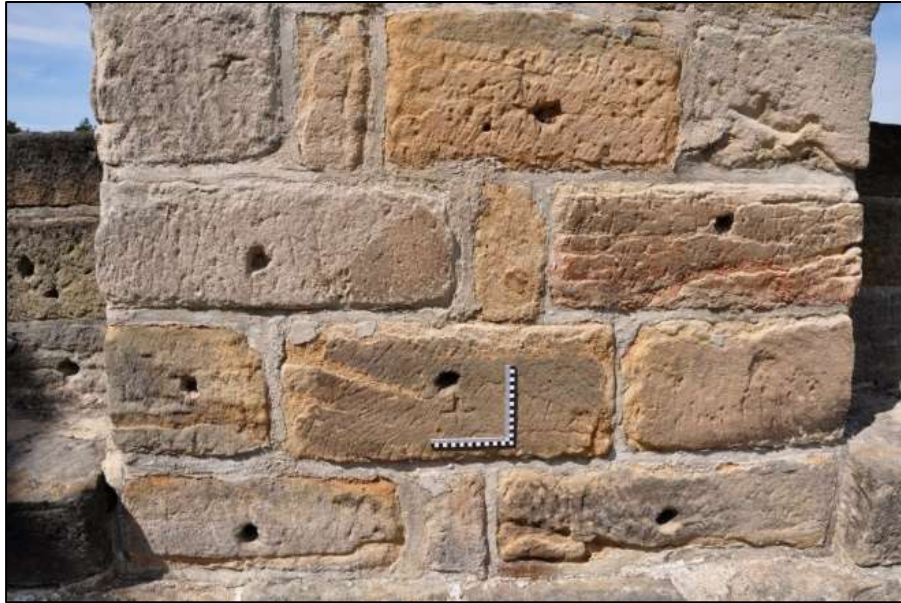
*Various traces on the surface of the wall: signs of transportation, tool marks, stonemason's mark, traces of weathering and aging*

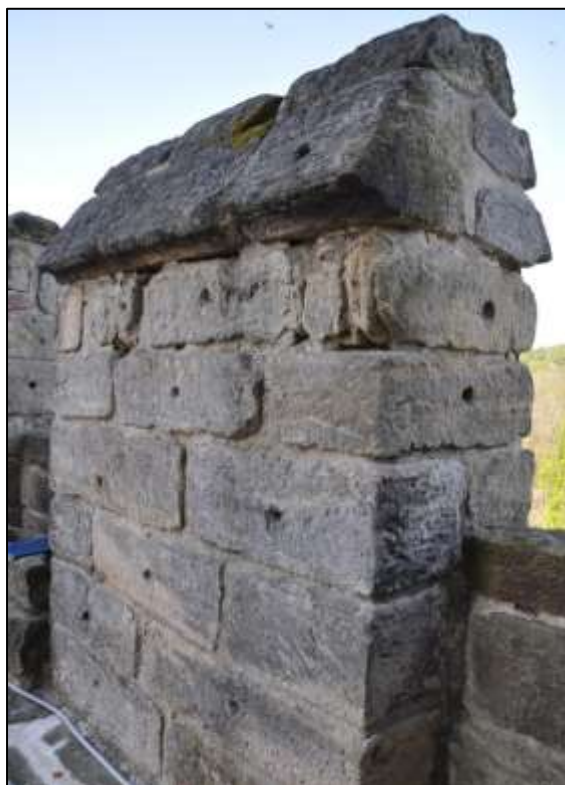
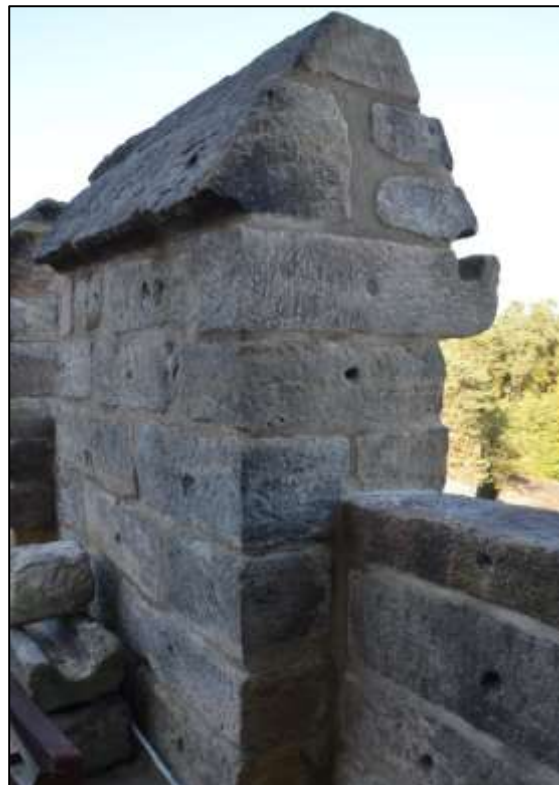
*One of the merlons on the battlements before and after the repair*

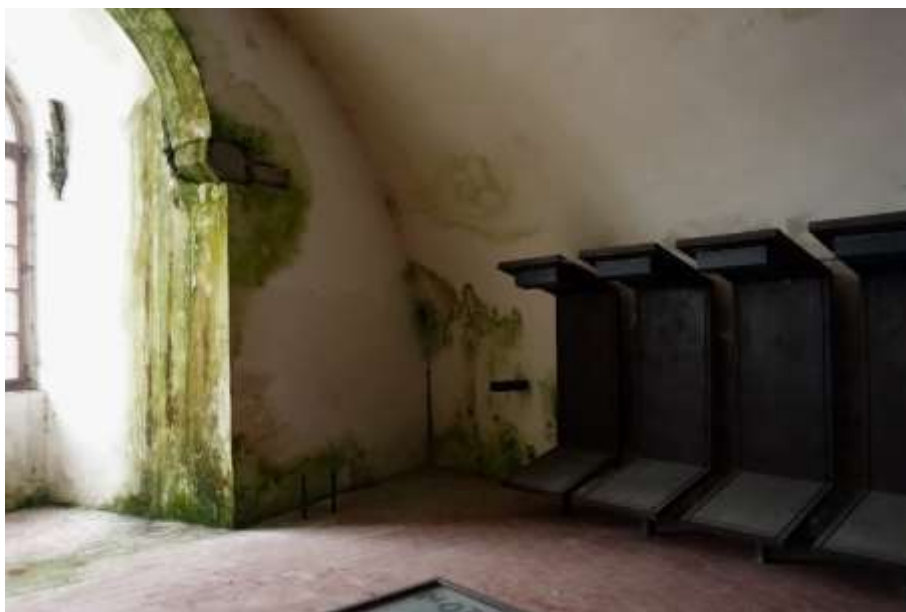
*High humidity in the interior of the Great Towers (photo Lucie Bláhová 2017)*

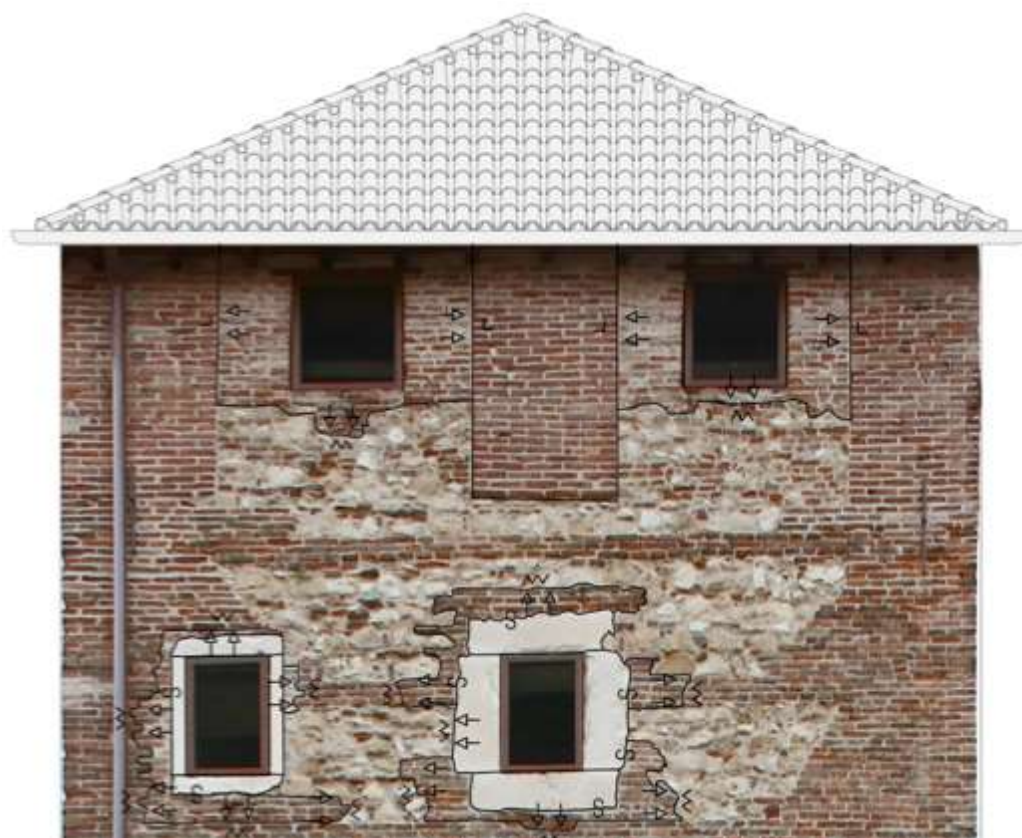
Image 2: extract of stratigraphic analysis

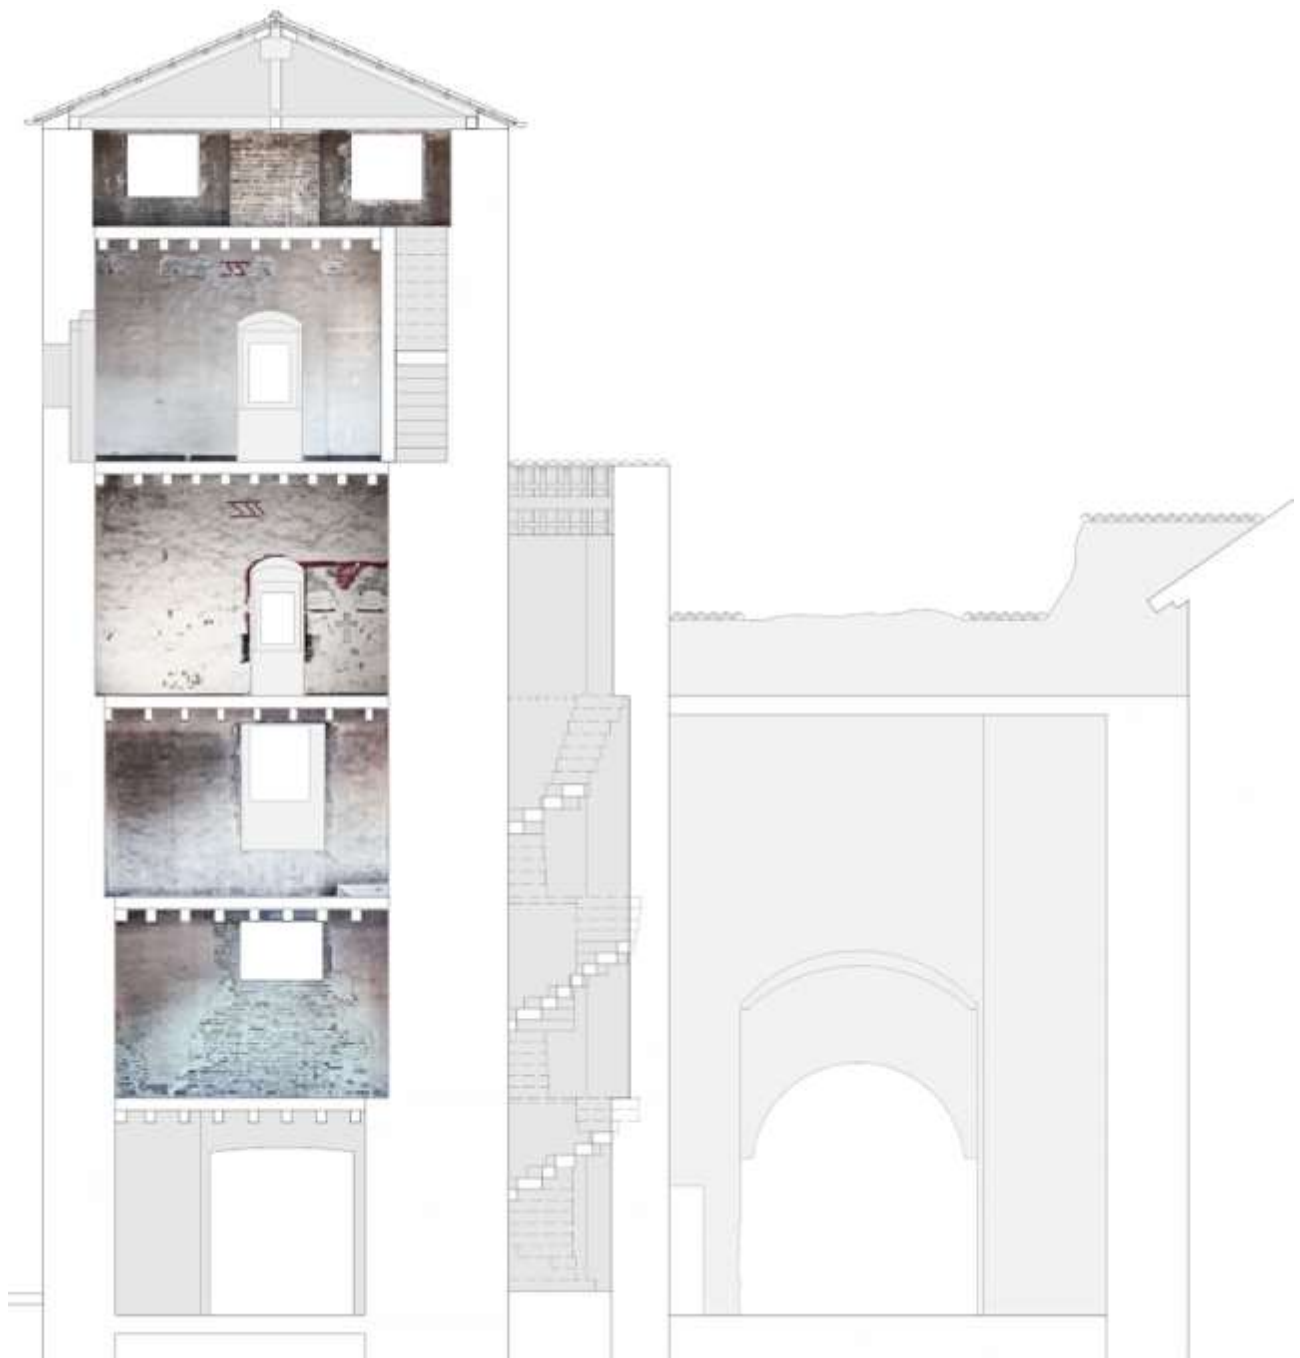
Image 3: section with image straightening of internal walls

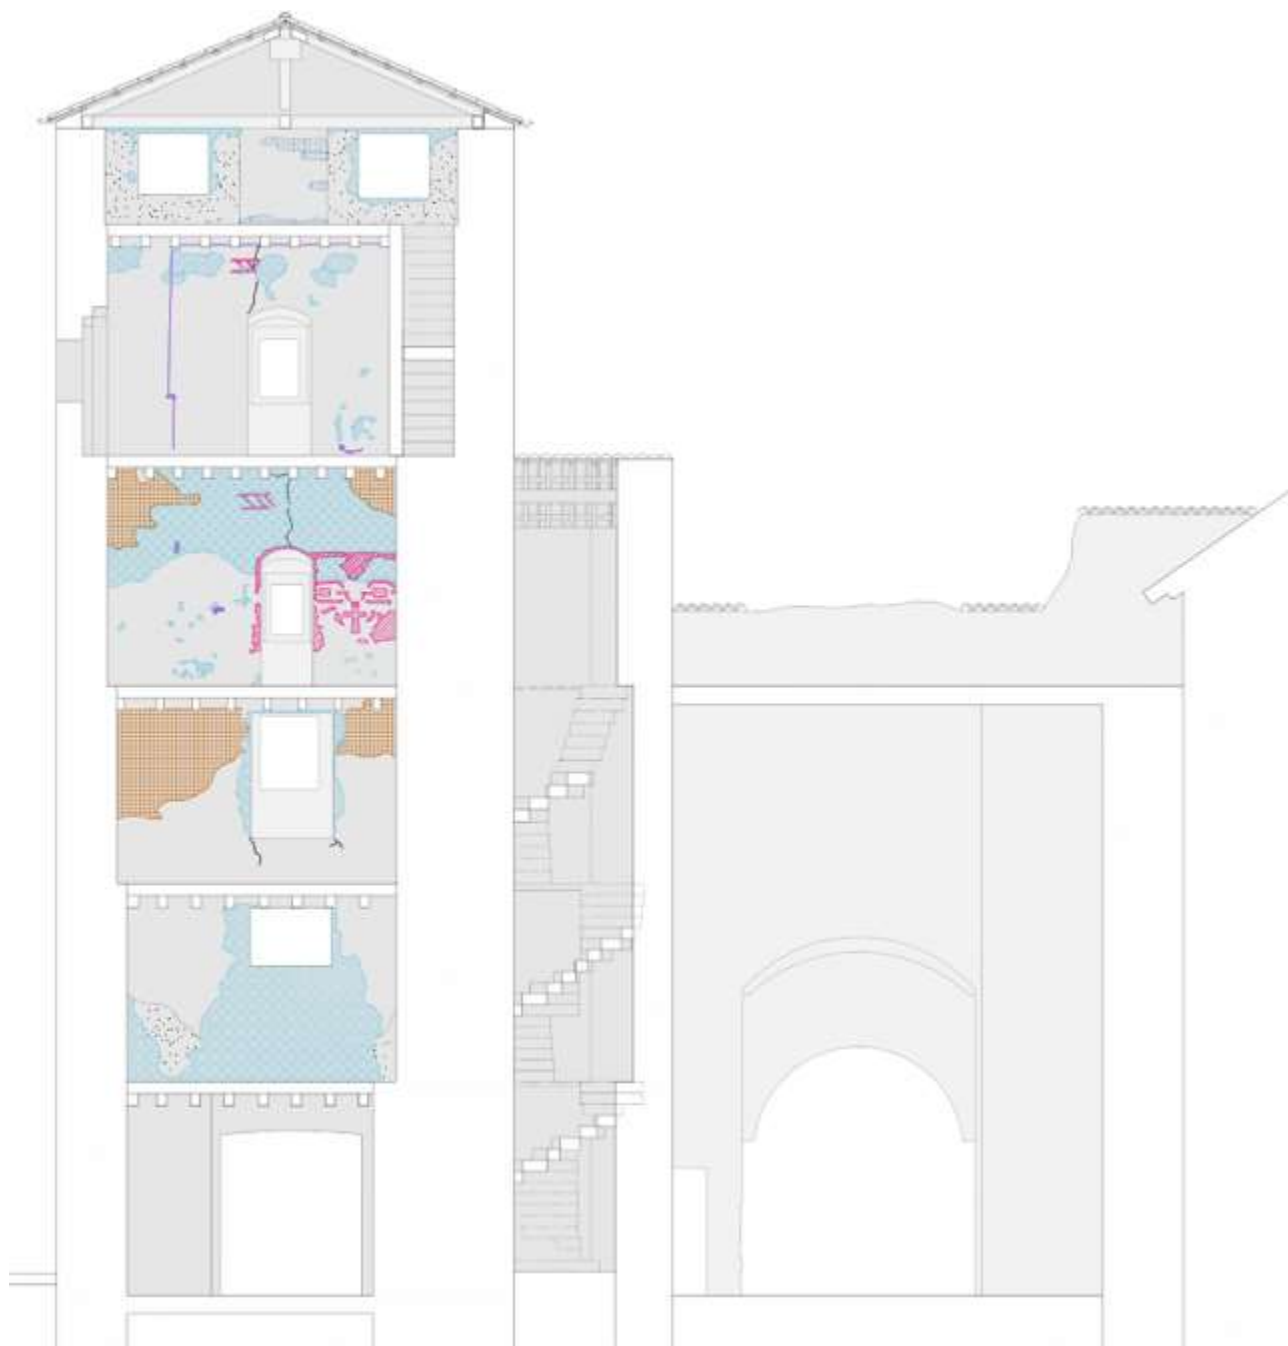
Image 4: degradation analysis through screening method

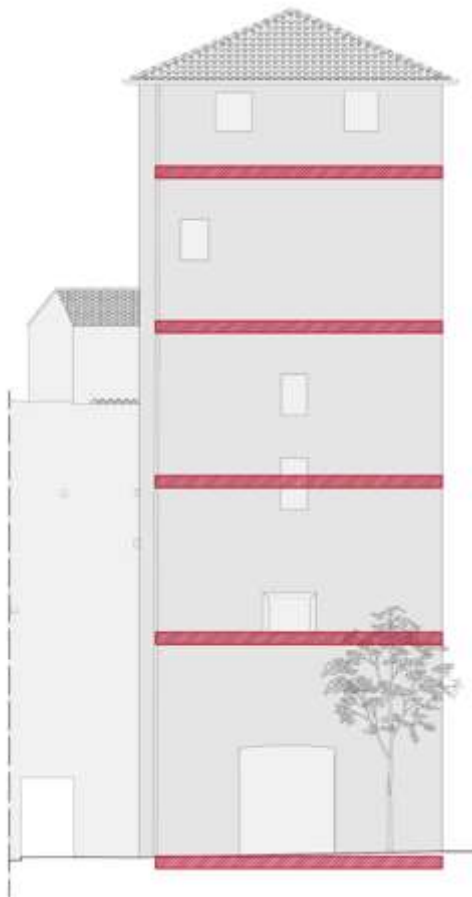
Image 5: position of the beams

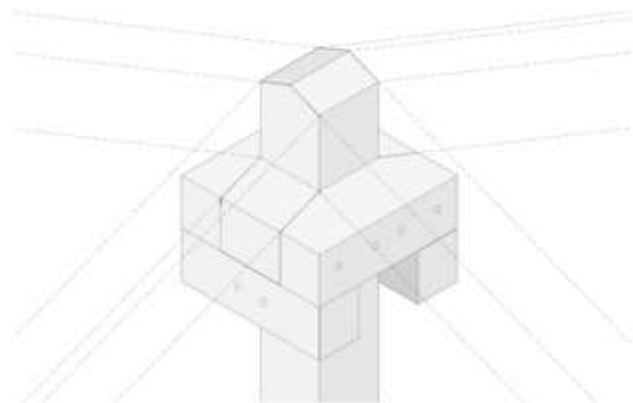
Image 14: trusses (detail)

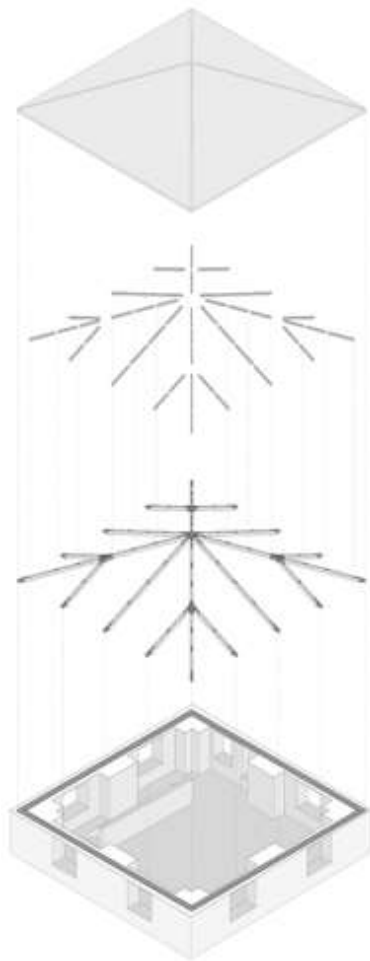
Image 15: construction system
