MONASTERY IN BZOVÍK – VALUE ASSESSMENT AND MANAGEMENT PLAN

Authors: Martin Miňo, Zuzana Klasová, Hana Chorvátová, Ingrid Turisová, Ivan Murin, Peter Andráš, Pavol Midula, Ján Spišiak, Jana Jaďuďová, Kamila Borseková, Anna Vaňová, Iveta Marková

This publication is written as a part of the project **RUINS CE092: Sustainable re-use, preservation and modern management of historical ruins in Central Europe**, financed by the European Fund for Regional Development, within the program **Interreg CENTRAL EUROPE**.

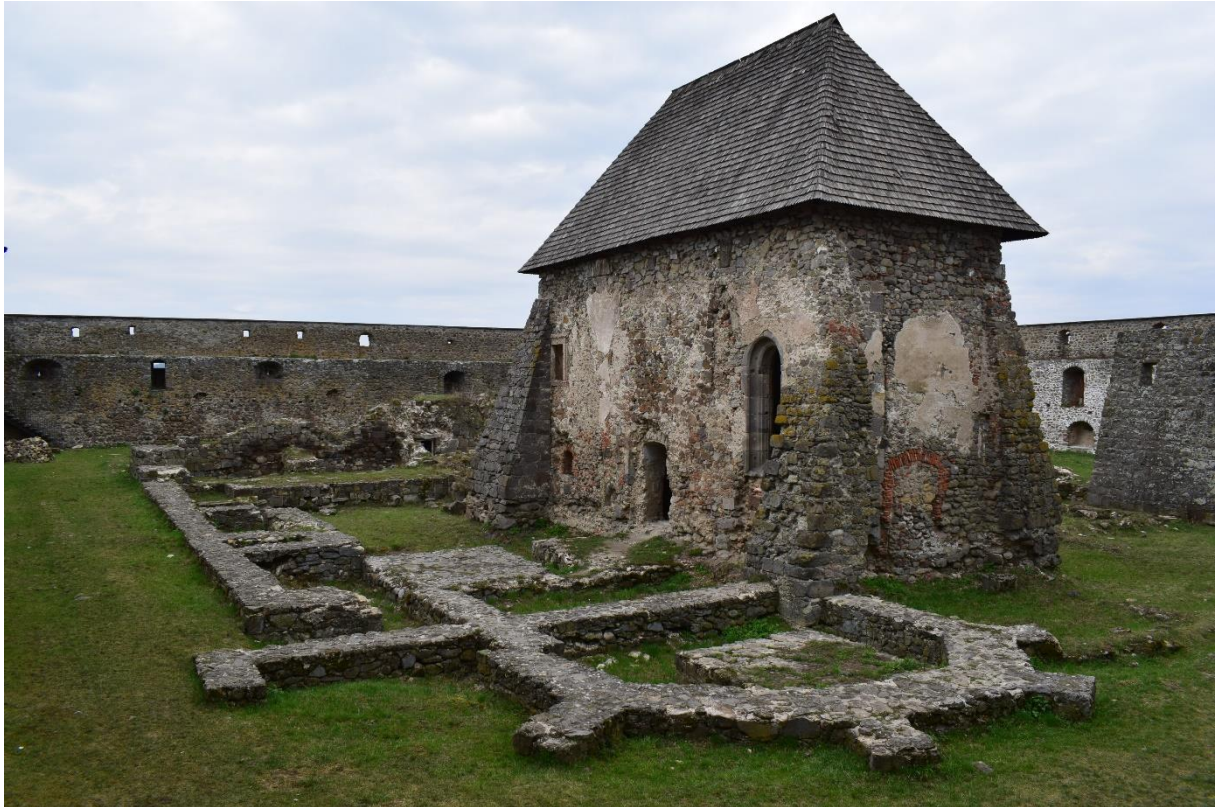
Figure 12 Presentation of the vanished church

The original construction look of the monastery church is not completely understandable due to the condition in which it has been preserved. The church was destroyed, most probably, during the attacks of people from Krupina, but latest during the adaptation of the site to serve as a castle and later a fortress. It was preserved at the level of foundations, along with several lines of above-ground masonry, as an archeological situation (Balaša 1969). After an archeological research, it is presented in a form of the original covered with stone masonry linked with cement mortar, which makes it rather difficult to read the details of the original. It is, however, clear that the church has gone through several construction stages. In the end, it resulted in being a three-nave basilica with a transept, polygonal presbytery sacristy in the northern part of the presbytery, and probably a narrow side chapel in the southern part of the nave. The western façade of the church was completed with two towers of which only the northern tower has been preserved up to one level. The church was built from stone masonry with the use of quarry stone laid on a lime mortar. This masonry was bolo covered with stone blocks on the outside. The material of the tower has core masonry laid by spiked weave. A relatively simple entry portal is located in the western façade. The main entry was probably through a profiled portal from the western corridor of the ambit located in the northern wall of the church. In the preserved material of the castle chapel, which partially covers the original sacristy of the monastery church, profiles of stone ledges on the exterior of the church are preserved. Plinth ledges are also partially preserved in the southern part. In front of the western façade is a vaulted room which could be a narthex. It is, however, more likely to be a later addition belonging to the castle or fortification period. The tower of the church was the only part of the church that remained in its original height until the 20th century, when it was destroyed, with the exception of the first above-ground level.

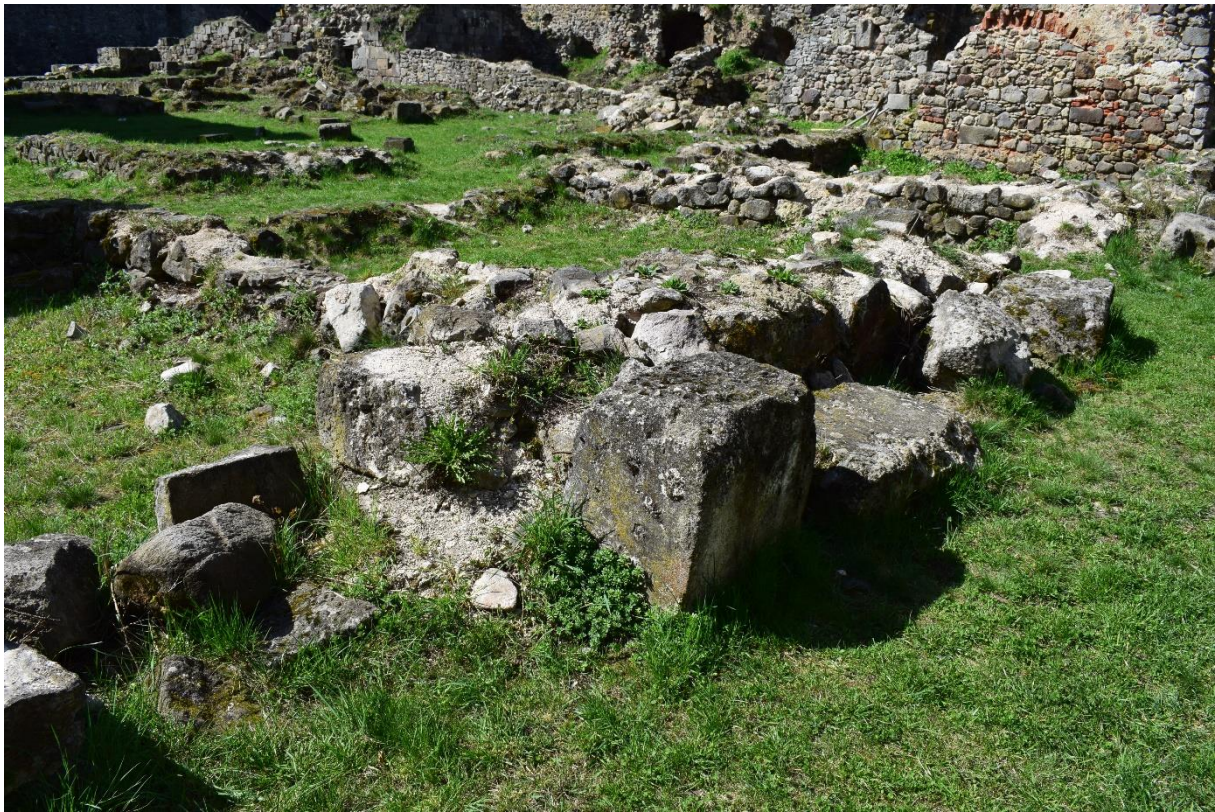
Figure 13 Ruins of the monastery quadrature

The monastery itself has a form of monastery quadrature, oriented around the central yard. The yard was surrounded by a cloister, which has full disposition of all four sides. The other spaces of the monastery are forming the northern, eastern, and western wings, while the southern wing served as the monastery church. At present, only small fragments of the above-ground monastery structures are preserved, mainly in the north-western corner of the quadrature, where a half of – most likely – a triumphal arch of the destroyed monastery chapel is also preserved. Other parts are distinctively reconstructed, or were fully rebuilt in the castle and fortification periods, when the eastern wing of the quadrature disappeared completely. After the reconstruction to castle/fortification architecture, it was a two-level two-wing object linked with the chapel through the eastern wing of a cloister, a corner oriel (bay) in the south-western corner, and massive supporting pillars. The northern wing was probably partially provided with the basement, with it now being filled up. On the façade of the northern wing, a stone signboard was placed, related to the Late-Gothic reconstruction of the monastery. Today, it is placed in the western defense wall of the Roman-Catholic church in the municipality. Today, the objects of the convention are only preserved as ruins (up to one above-ground level), which represent a sequence of rectangular rooms of approximately same dimensions, while the entry of a passage type was probably located in the northern wing (Faulhammer 1923, Mencl 1930a, Mencl 1930b, Könyöky 1889).

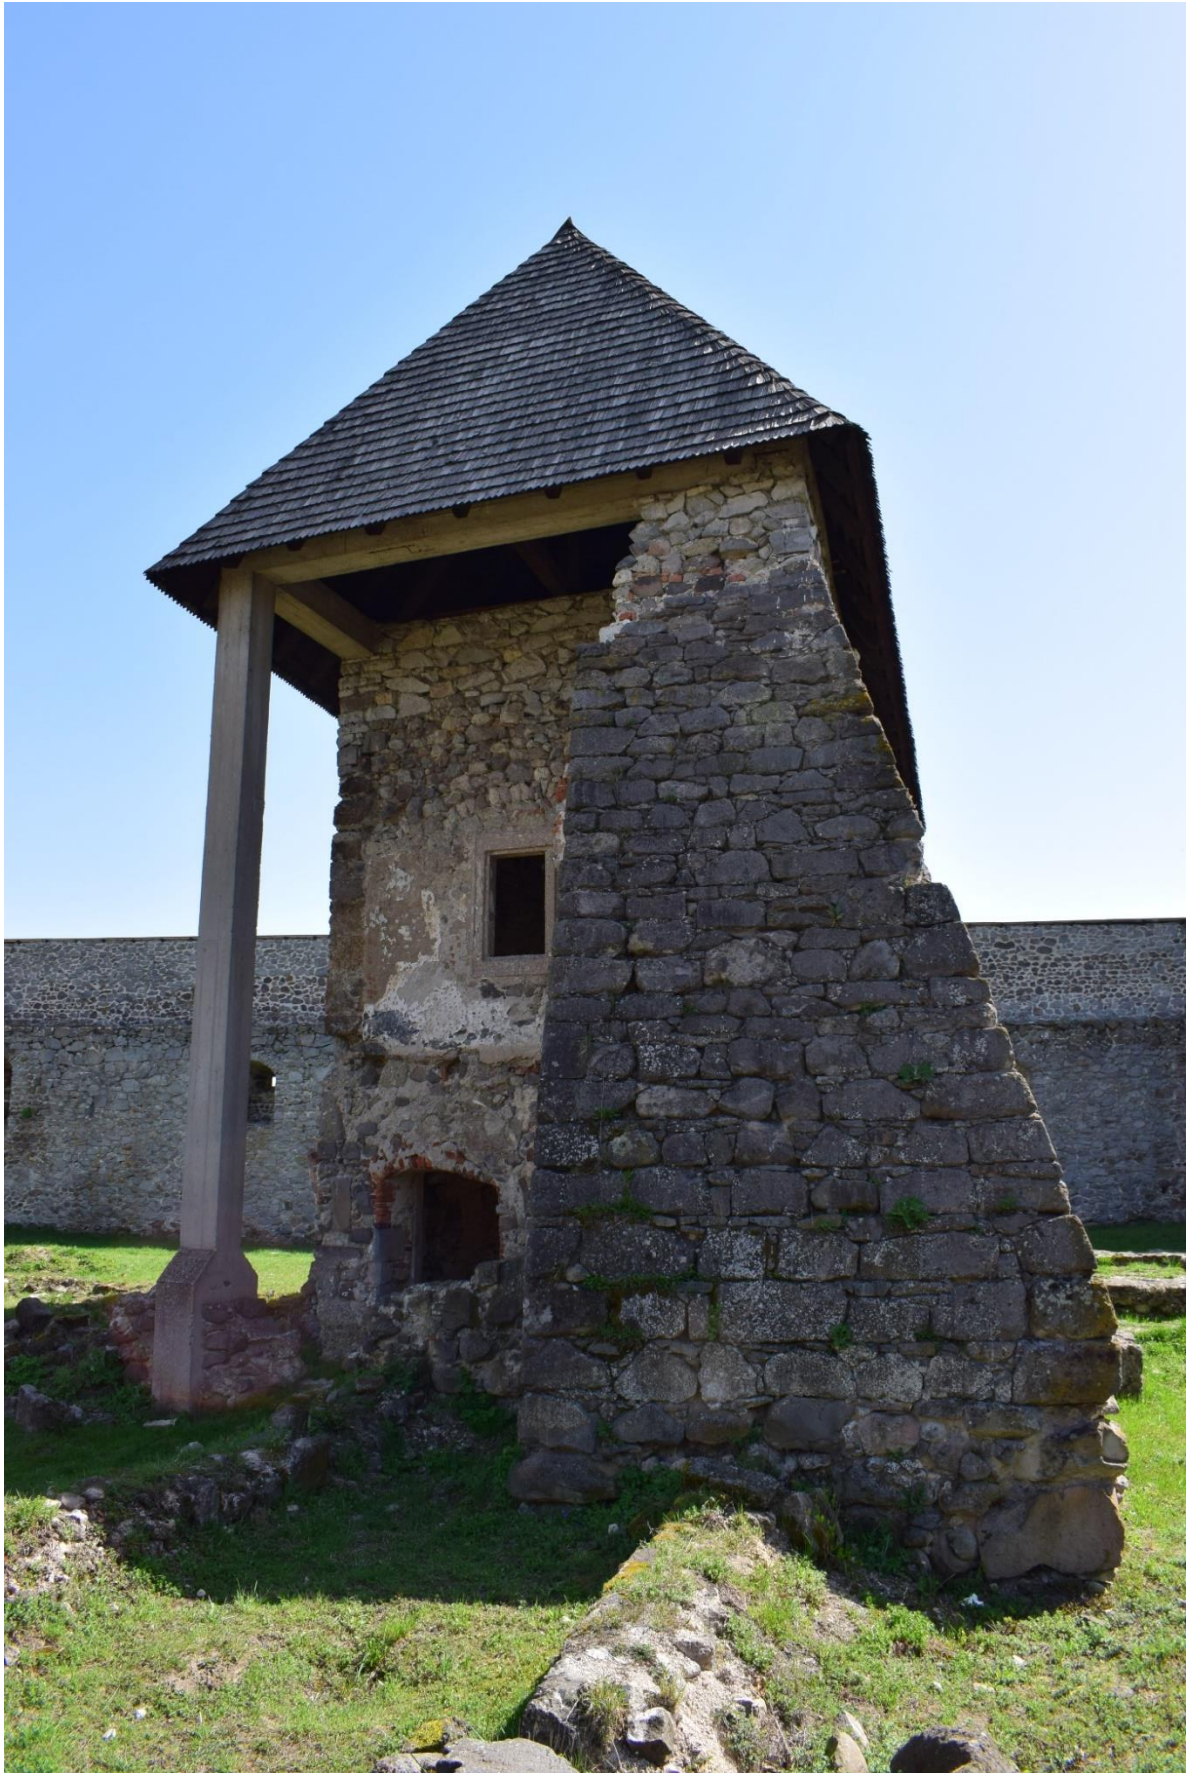
Figure 14 Chapel rebuilt from the original gothic presbytery of the monastery church

After the church had been destroyed, the role of the sacral building was played by the chapel, which was created by the reconstruction and addition of the original sacristy of the church. It is a single-nave building of approximately rectangular ground plan. From the south and north, the light comes in through two high Gothic windows with profiled components. The windows were only set in this position secondarily. The entry to the chapel is from the south, from a space where the original church stood, and from the west, from the corner between the southern and eastern parts of the ambit. A two-part Renaissance window is located in the western façade. On the inside a stone floor and the remains of the altar refectory, in place of the previous Baroque altar with three tables are located. The main altar painting from the chapel can be found in the Roman-Catholic presbytery in Bzovík.

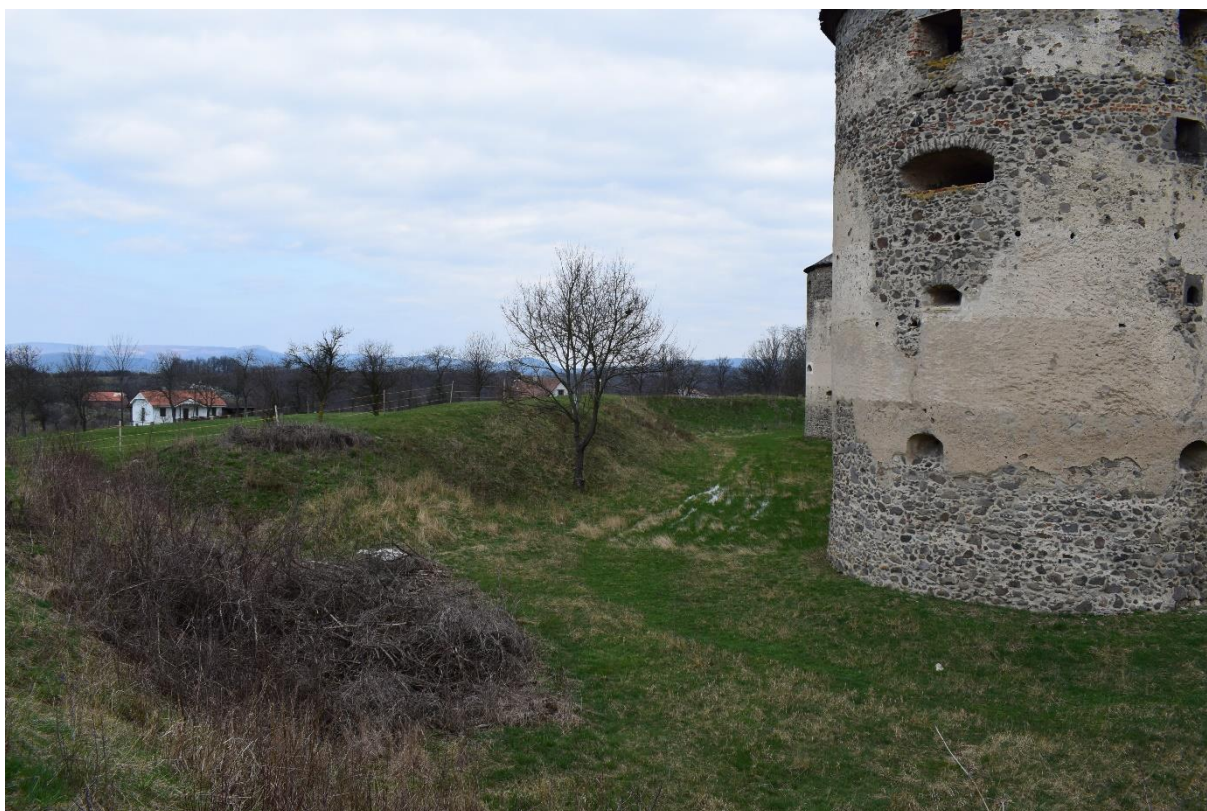
Figure 15 View of all lines of the fortification

The castle wall has a form of a curtain wall with three levels of loopholes. On the ground level, each loophole is located in the center between two bastions with outwardly extended reveals, on the second level the “line of loopholes” is located. Next to the bastions, these are replaced by loopholes with outwardly extended reveals. The middle level was serviced from a wooden porch, of which, only beam beds are preserved. The upper line was located in the upper part of the castle and contained narrow loopholes. The whole upper line was passable around the whole area.

The whole fortification is surrounded by a moat, while the masonry fortification in fact forms the scarp of the moat. The opposite side of the moat is not reinforced, and glacis is piled around its edge. The moat is rather wide, and dug into a terrain. It is dry, only in the western and southern parts, rainwater occasionally collects. In front of the defense wall, a newer loose fortification, described above, is located. On the glacis by the entry bridge, the remains of a pedestal of the Jan Nepomucky Baroque statue can be found, while the statue itself has been dispossessed. There is a preserved copy, which is deposited in the studio of academic sculptor Ján Filo in Vlkanová, and its installation on the original, rather destroyed pedestal, is planned.

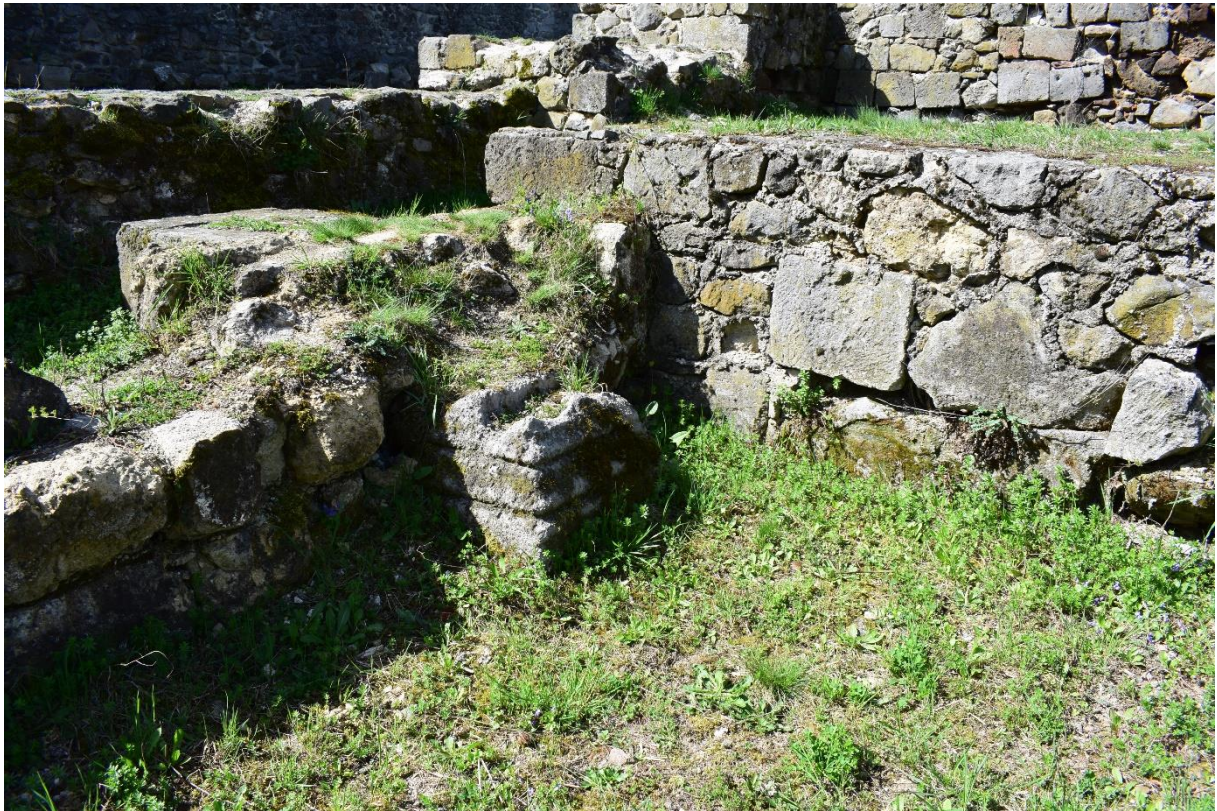
Figure 16 The foot of the pilaster carrying the cross vault of the church

The church is completely destroyed, only several lines of above-ground masonry are preserved. Of little information about the interior we now have, we can say that it was arched with a cross vault, the feet of which were based on pilasters placed at the terrain level. Some are preserved by the southern wall of the church. In the presbytery, there were two underground single-space crypts, which are inaccessible at this time. In the end of the presbytery, a foundation of a sacrificial table can be found. Since the church had already been destroyed in the end of Middle Ages, there are no

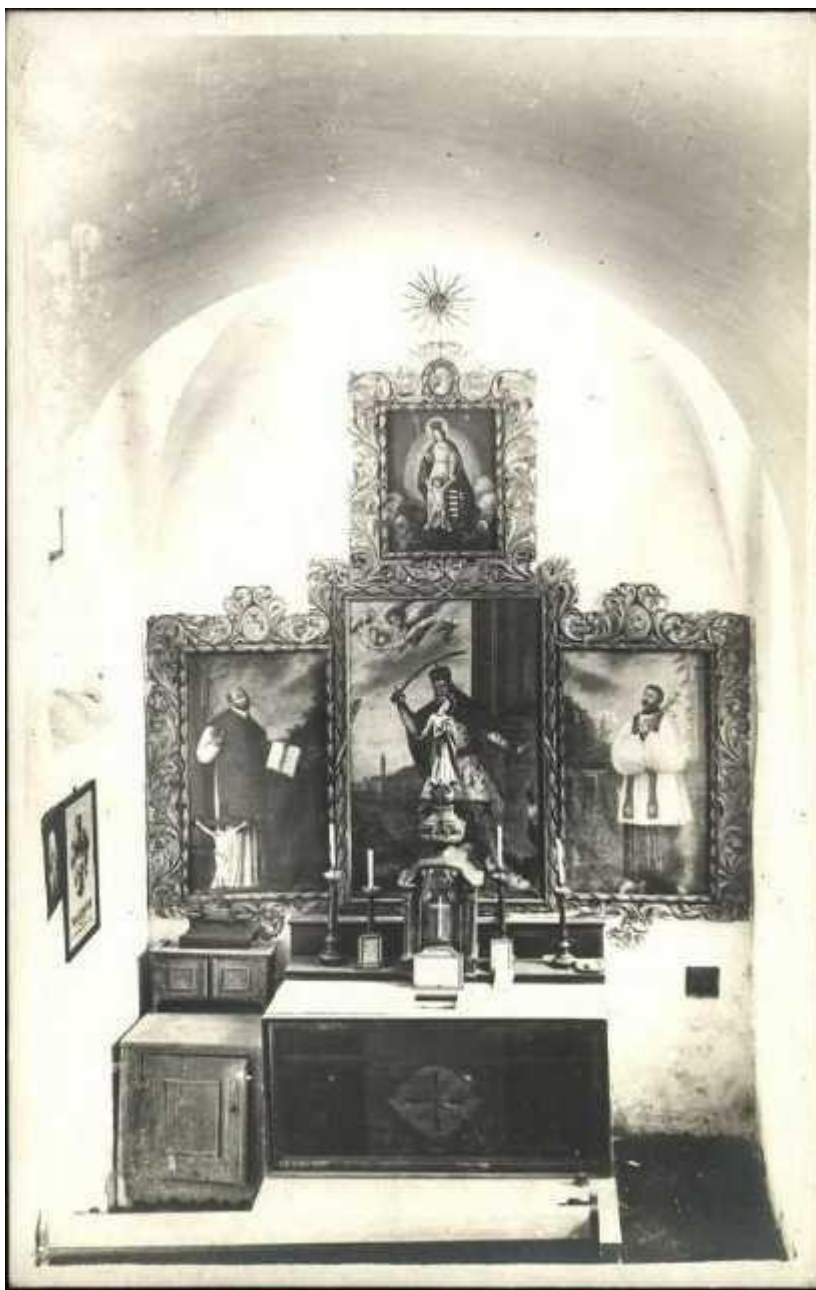
Figure 17 the inside of the chapel at the beginning of the 20th century and now

The chapel was founded as a substitution to the church, and was reconstructed from the original sacristy. This corresponds to its simple confined interior. Inside, the chapel was arched with a barrel vault with lunettes in the place of windows, which has not been preserved. At present the ceiling is open to the roof frame of the newly shaped roof. The interior was originally covered with lime plaster with white monochrome coating. The sacrificial table with a Renaissance altar, which was illuminated by the side lights from the side windows, was in the eastern part. The walking terrain was formed by a simple stone floor of gray sandstone slabs, which has been quite well-preserved until today.

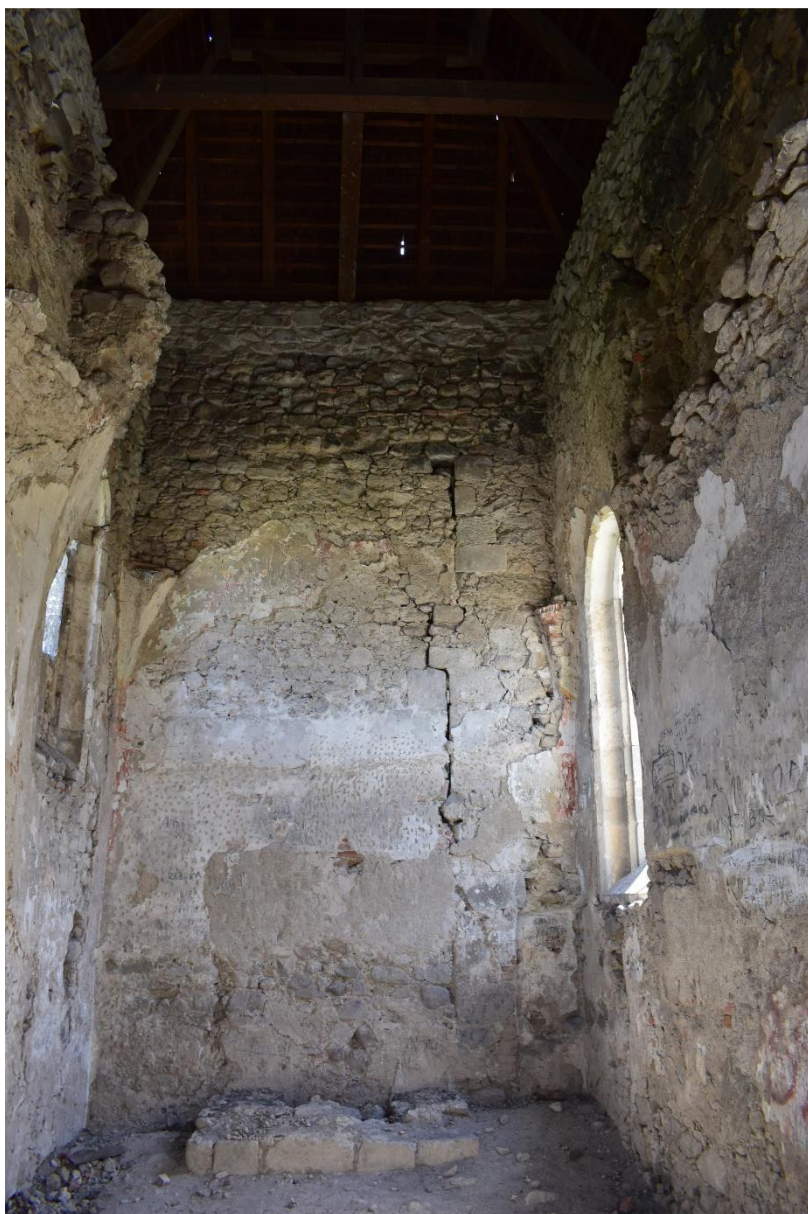
Figure 18 Historical photography of the inside of the cloister from the beginning of the 20th century

They are preserved rather torsionally. At the moment, there is no known picture documentation which would depict the interior of any space within these objects before they were destroyed. The only lead is a unique historical photo of the cloister, which at that time was already closed with a cross vault, white monochrome walls, and the floor made of burned brick. Another lead is the construction survey from 1920s and 1930s by V. Mencl and Faulhamer (1930; 1923), where on the ground level, forms of vaults are documented as well. From his documentation, we may say that in at least two spaces of the wing, Late-Gothic cross vaults were very likely preserved. The western wing had younger, barrel vaults with lunettes.

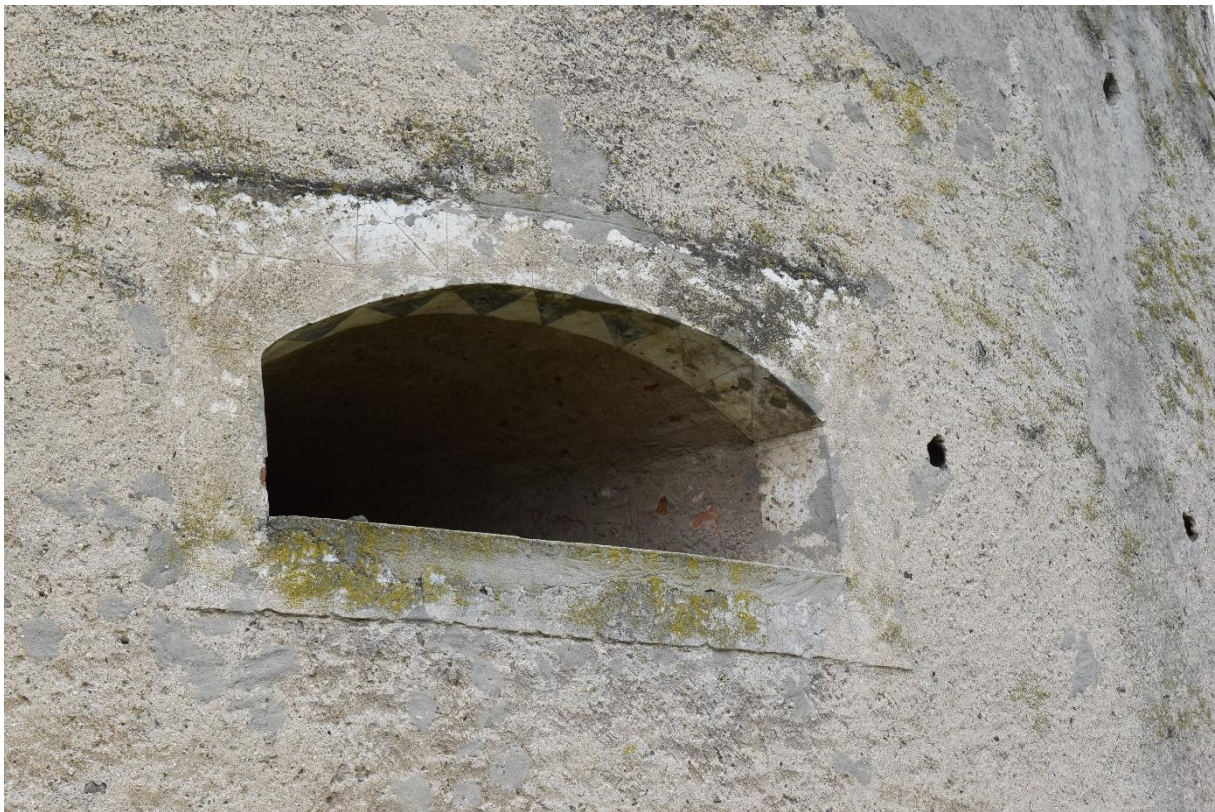
Figure 20 Typical decoration of the loopholes on the fortification bastions

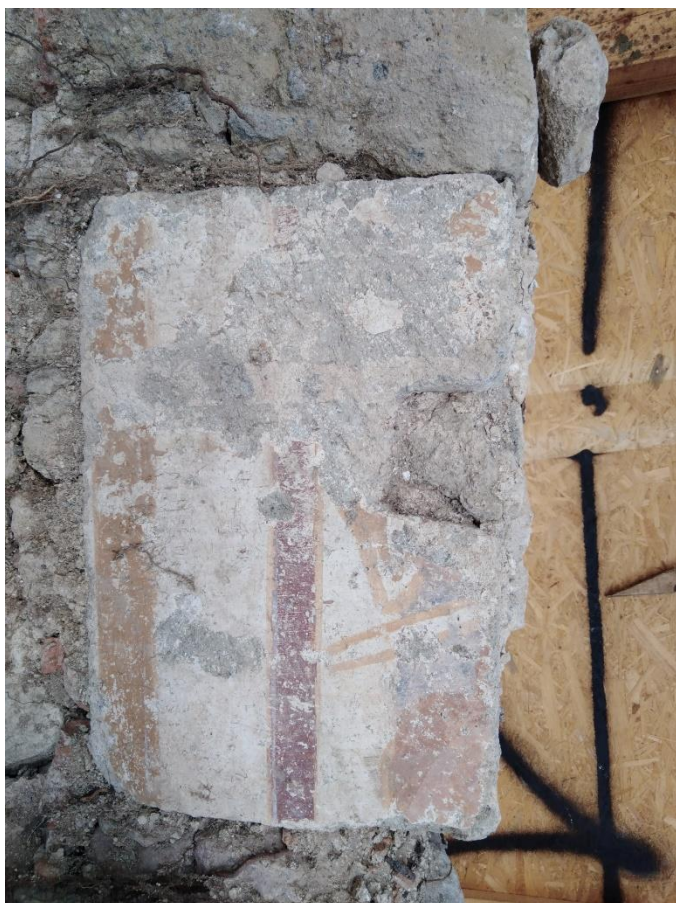
Figure 21 Fragment of the mural from the vanished monastery church on the block used secondarily in the masonry of the western wing of the residential part of the castle

No interior murals are preserved, and there is no evidence for their existence. The only lead is a small fragment preserved on a stone block of the (probably) originally Roman monastery church, used secondarily in younger masonry of the western wing. It is a fragment of what appears to have been a big mural. The fragment represents a linear bordure in ocher and red colors, with a small fraction of the scene itself – in ocher. Compared to the other preserved historical art pieces, the mural could fall into the context of the 13th century.

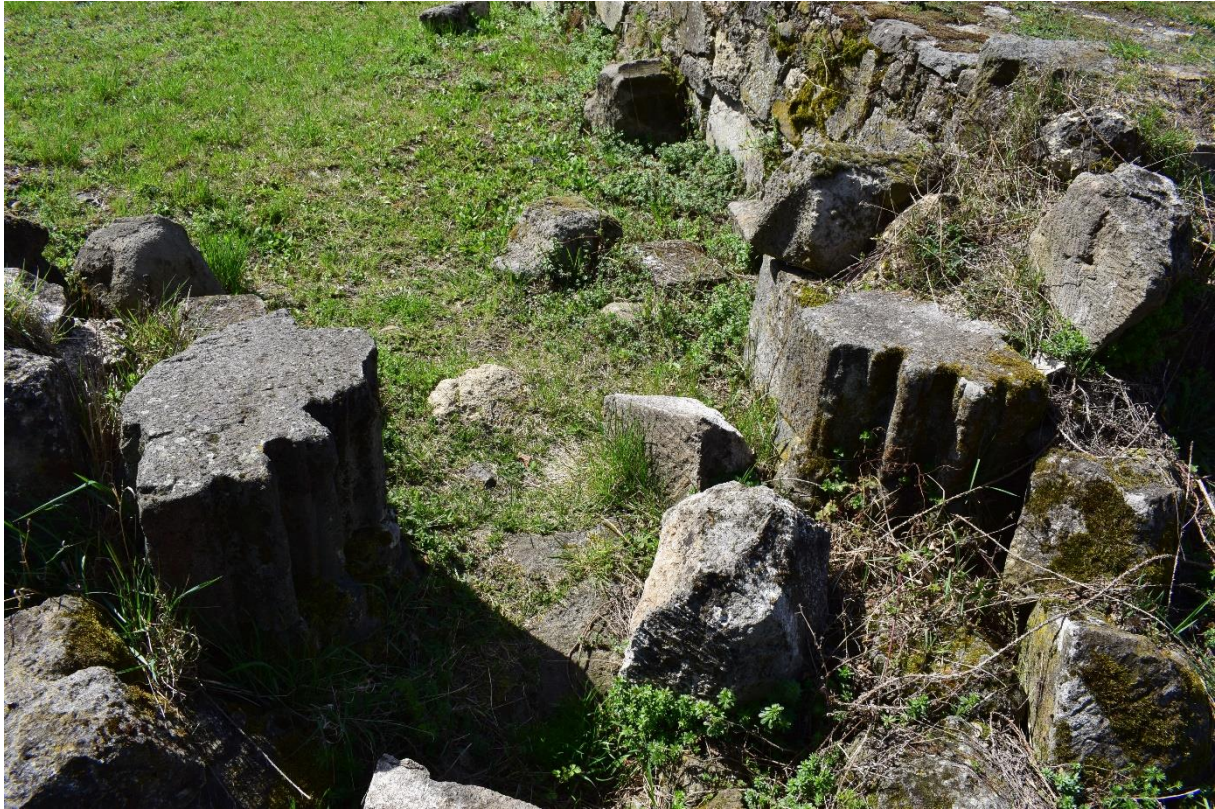
Figure 22 the bottom part of the Roman portal of the monastery church

Stone elements that are preserved from the Roman period are only fragmented, while it is mainly the lower/bottom parts of the profiled portal in the northern wall of the church leading to the western wing of the cloister.

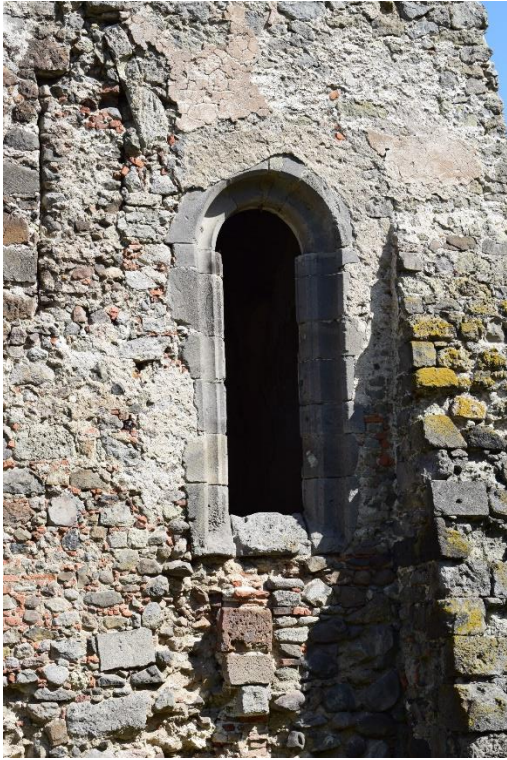
Figure 23 Gothic window with a tracery from the extinct church, secondarily reassembled during the conversion of the sacristy into a chapel

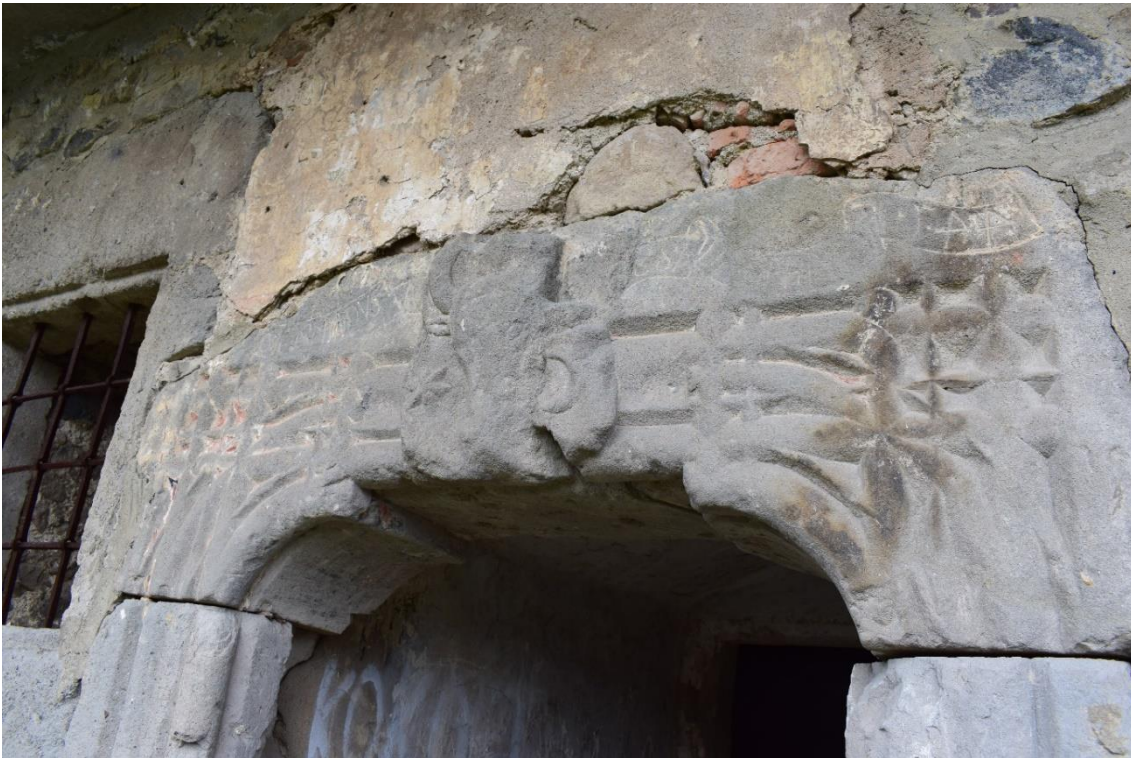
Figure 24 Late-Gothic saddle portal into the North-Eastern tower with the embossed heraldic decoration depicting the Balass coat of arms

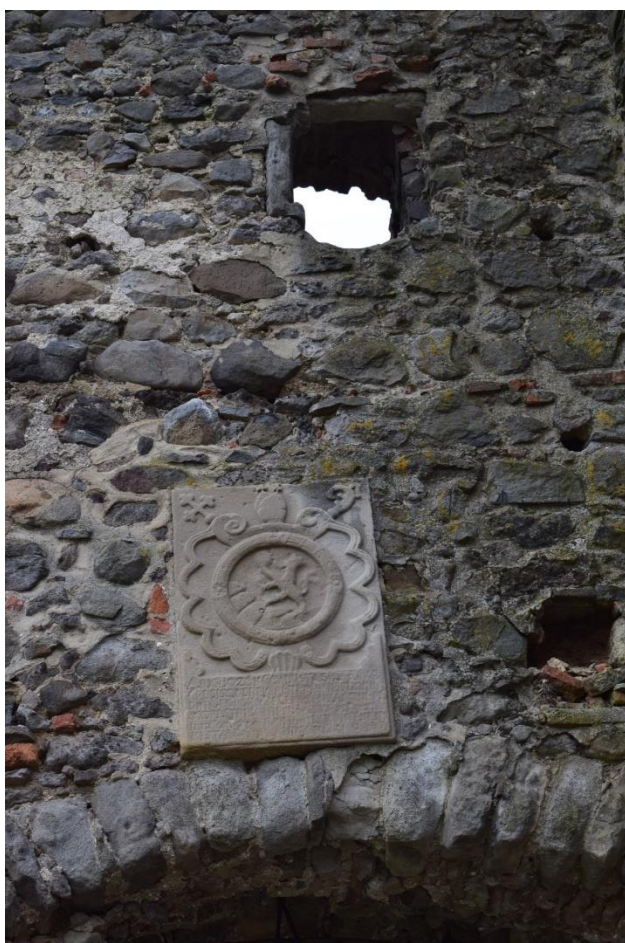
Figure 25 Commemorative plaque to the reconstruction of the object in 1680 with the coat of arms of Juraj Selepcény

There are only few Renaissance stone elements, while it is mainly rather large rectangular window frames in the bastions. These are simple elements, which are on the inner side and are flat – not profiled. On the exterior, they have hollow for installation of the wooden frame, and on the bottom, a profiled ledge. Most frequently, the windows were covered with simple threaded bars, installed on the outside or from a reveal of the stone trimming. The Renaissance period is also represented by a sign board from 1680, with Selepcény's coat of arms, which relates to the Renaissance period of the reconstruction, above the main gate.

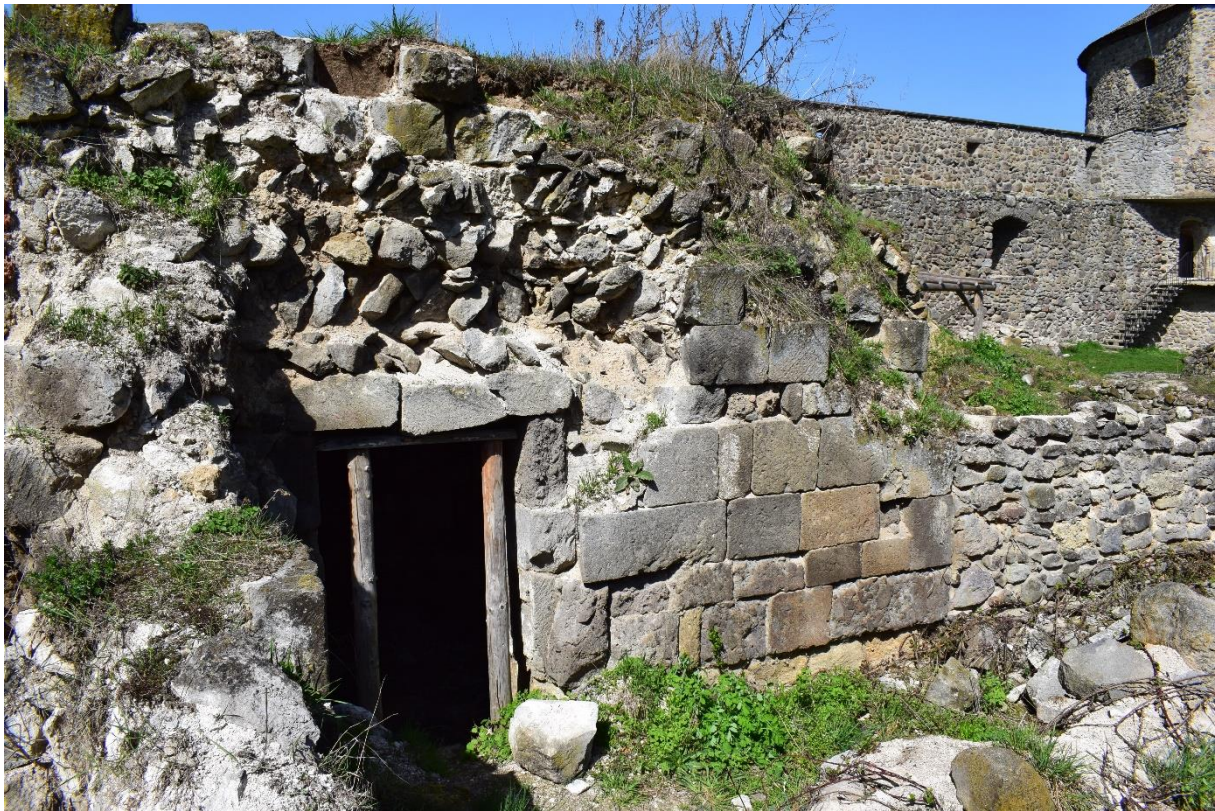
Figure 26 Block masonry with a core in a spiked weave in the northern towers of the monastery church

The external and the internal sides of masonry are formed by hewed stone blocks, while the core of the masonry is filled with quarry stone laid in spiked weave (*opus spicatum*). Masonry of this type was found in the torso of the northern tower of the Roman church. This type of masonry is unique within a broader geographical frame.

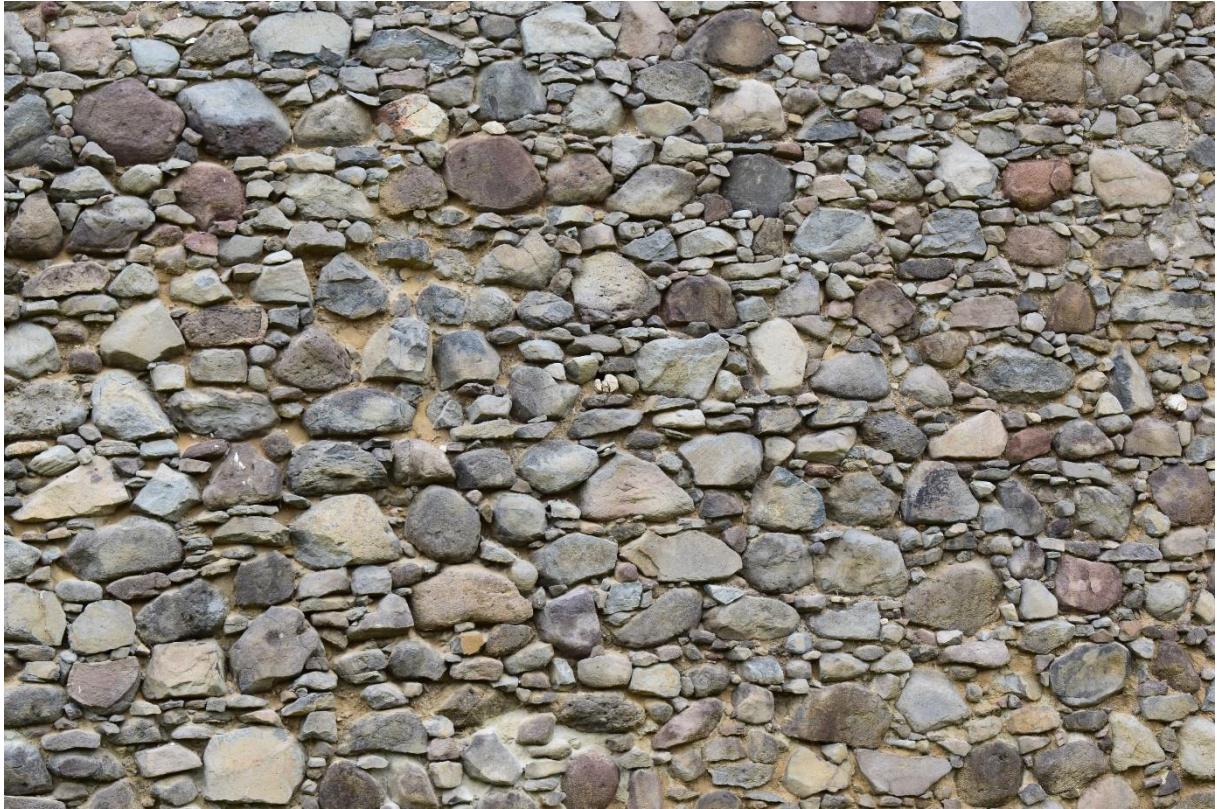
Figure 27 Quarry masonry from the quarry stone – the most common type of building structure

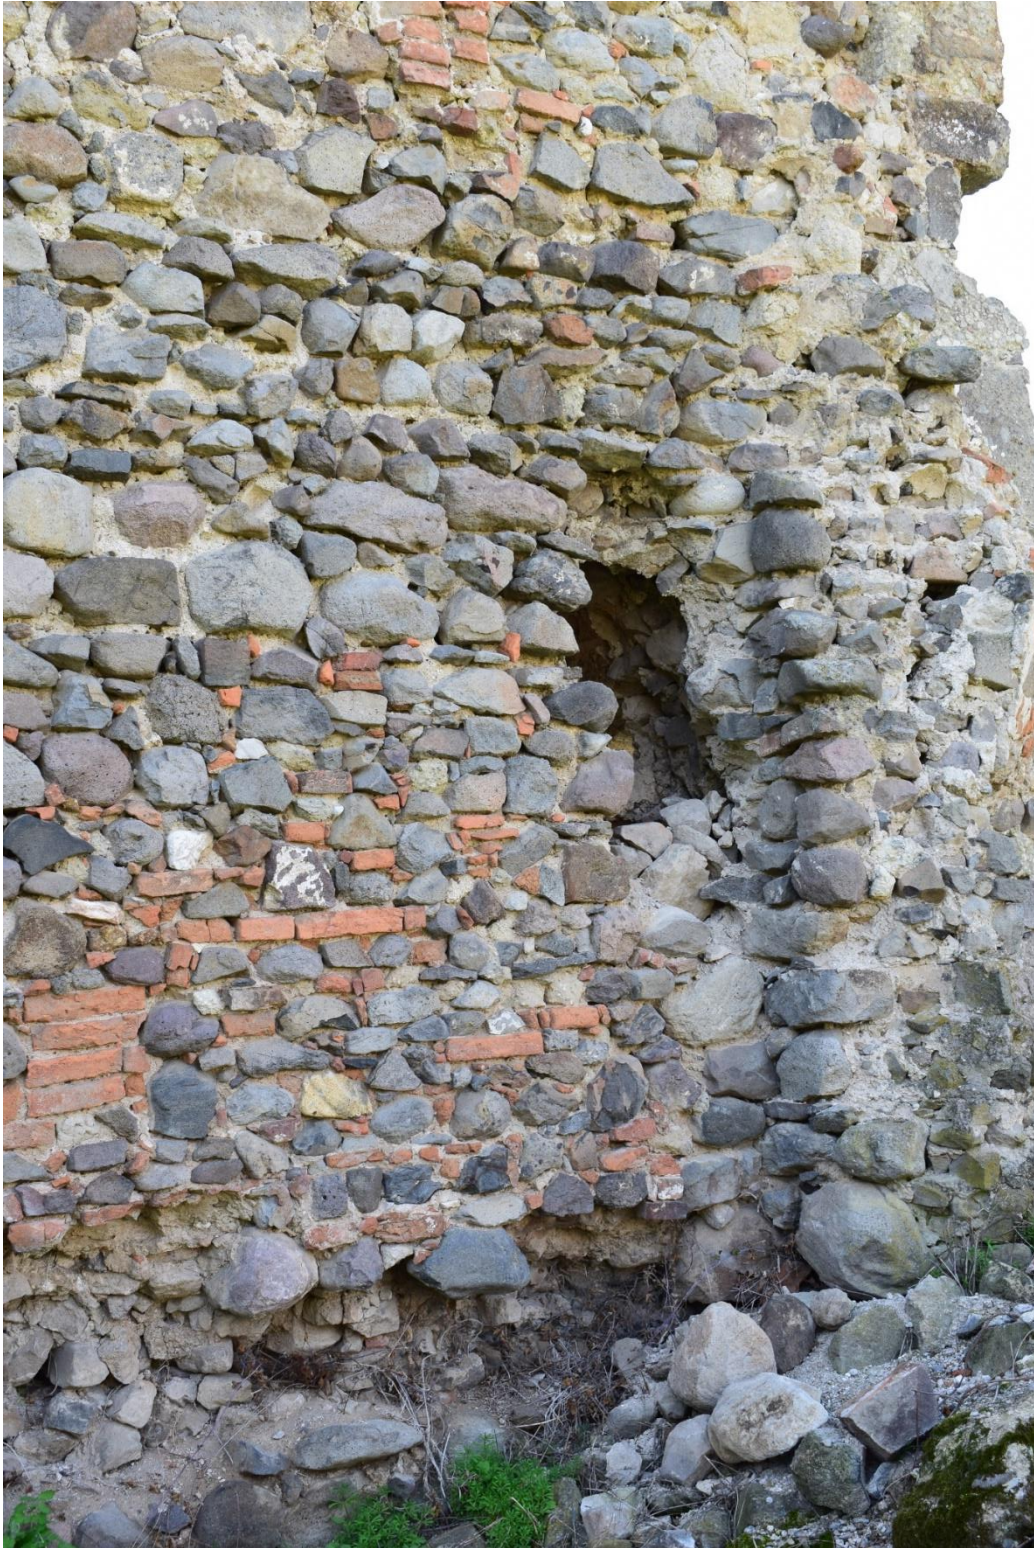
Figure 28 Detail of mixed masonry

This is masonry of a similar characteristics as the previous category with one difference – that wedging of the space caused by different shape of the adjacent quarry stones uses burned brick, or its fragments. This masonry is mainly used in case of repairs after demolition of the secondary holes, or for secondary wall-ups of old holes in younger (later) time periods (mainly Baroque). This type of masonry is least frequently used on the object, also due to its low durability.

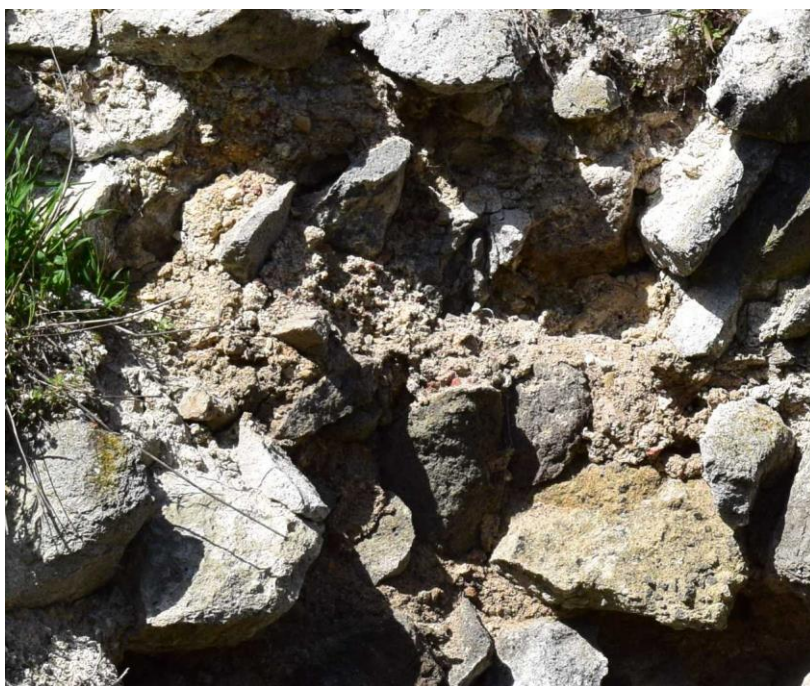
Figure 29 Detail of medieval mortar

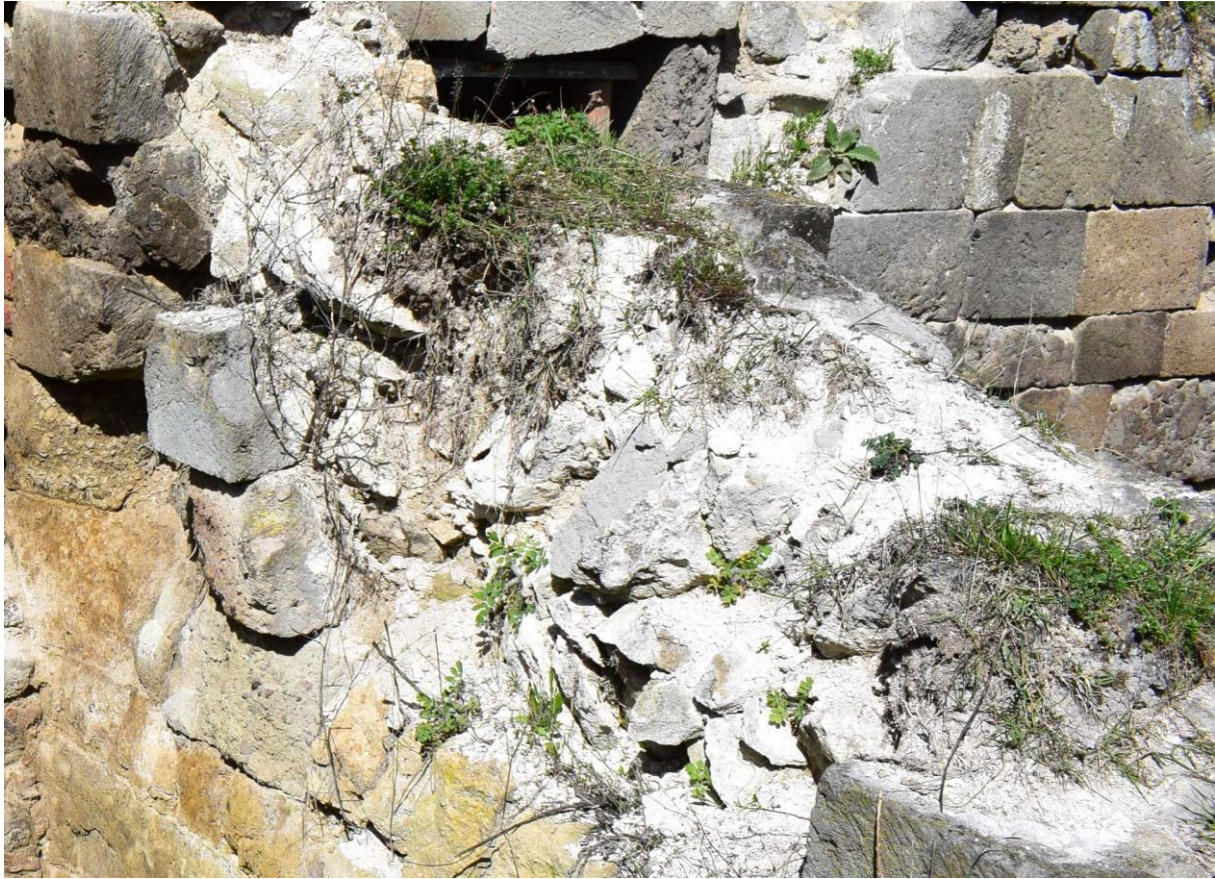
Figure 30 Detail of modern mortar

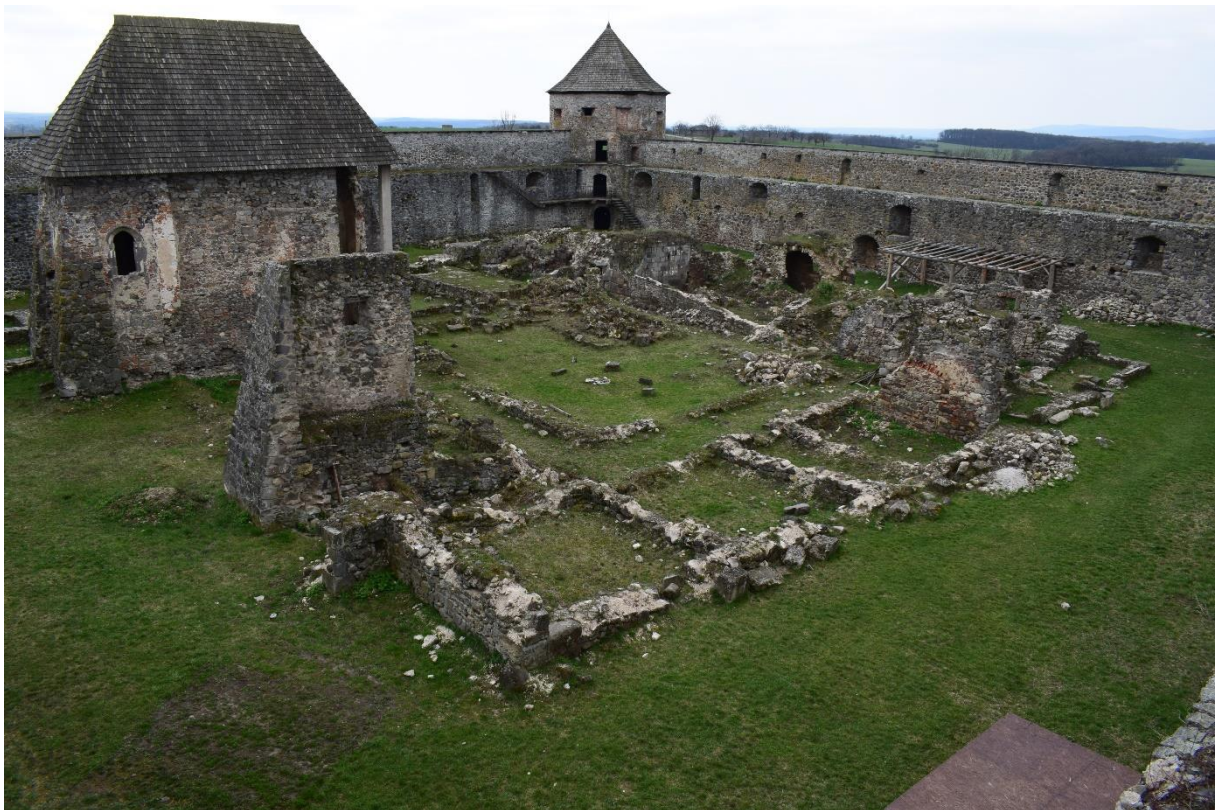
Figure 35 The overall view of the locality with the visible preserved urbanistic concept from the construction of the Roman Monastery, maintained despite significant historical reconstructions

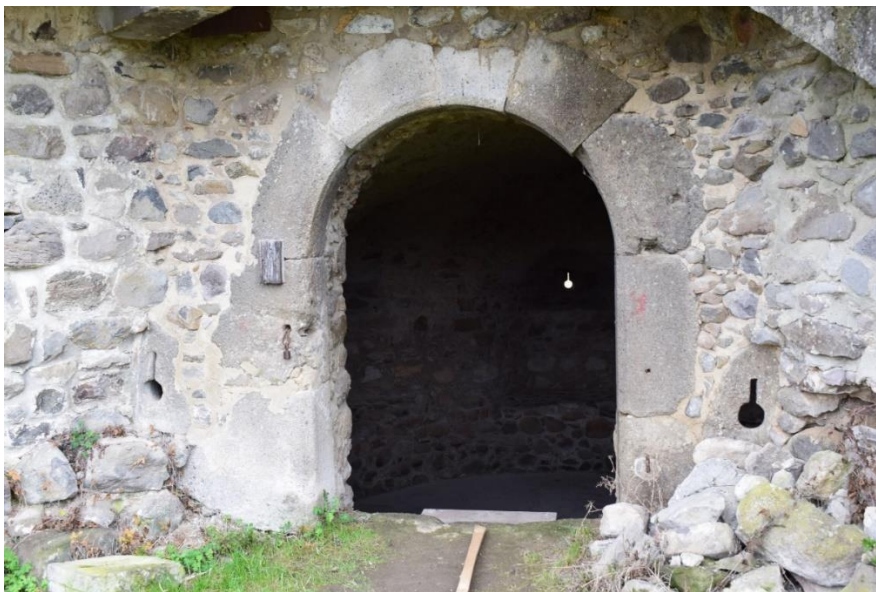
Figure 36 Negatively affecting adaptation elements: a) incorrectly reconstructed details b) invasive installation of engineering networks, c) reversible communication elements
