MONASTERY IN BZOVÍK – VALUE ASSESSMENT AND MANAGEMENT PLAN

Authors: Martin Miňo, Zuzana Klasová, Hana Chorvátová, Ingrid Turisová, Ivan Murin, Peter Andráš, Pavol Midula, Ján Spišiak, Jana Jaďuďová, Kamila Borseková, Anna Vaňová, Iveta Marková

This publication is written as a part of the project **RUINS CE092: Sustainable re-use, preservation and modern management of historical ruins in Central Europe**, financed by the European Fund for Regional Development, within the program **Interreg CENTRAL EUROPE**.

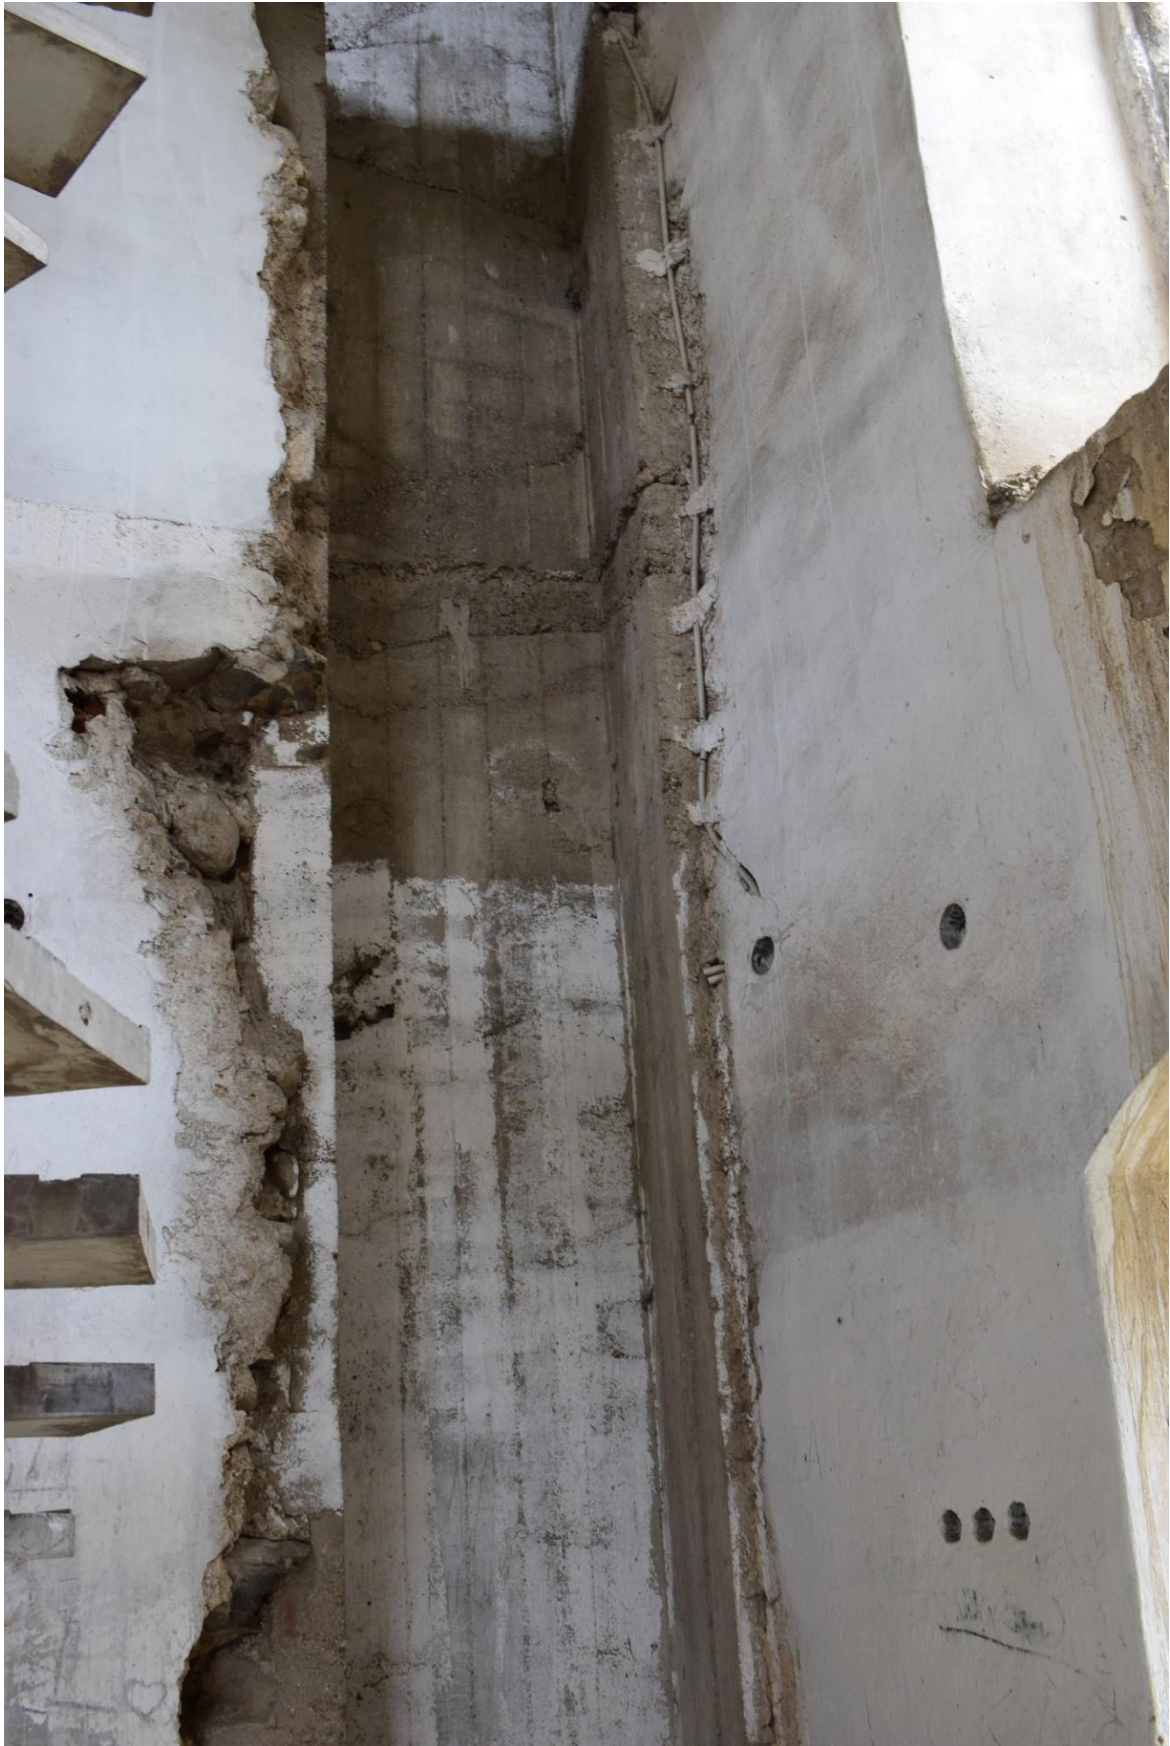
Figure 37 Appropriately done reconstruction of the fortifications with completions distinguishable from the original

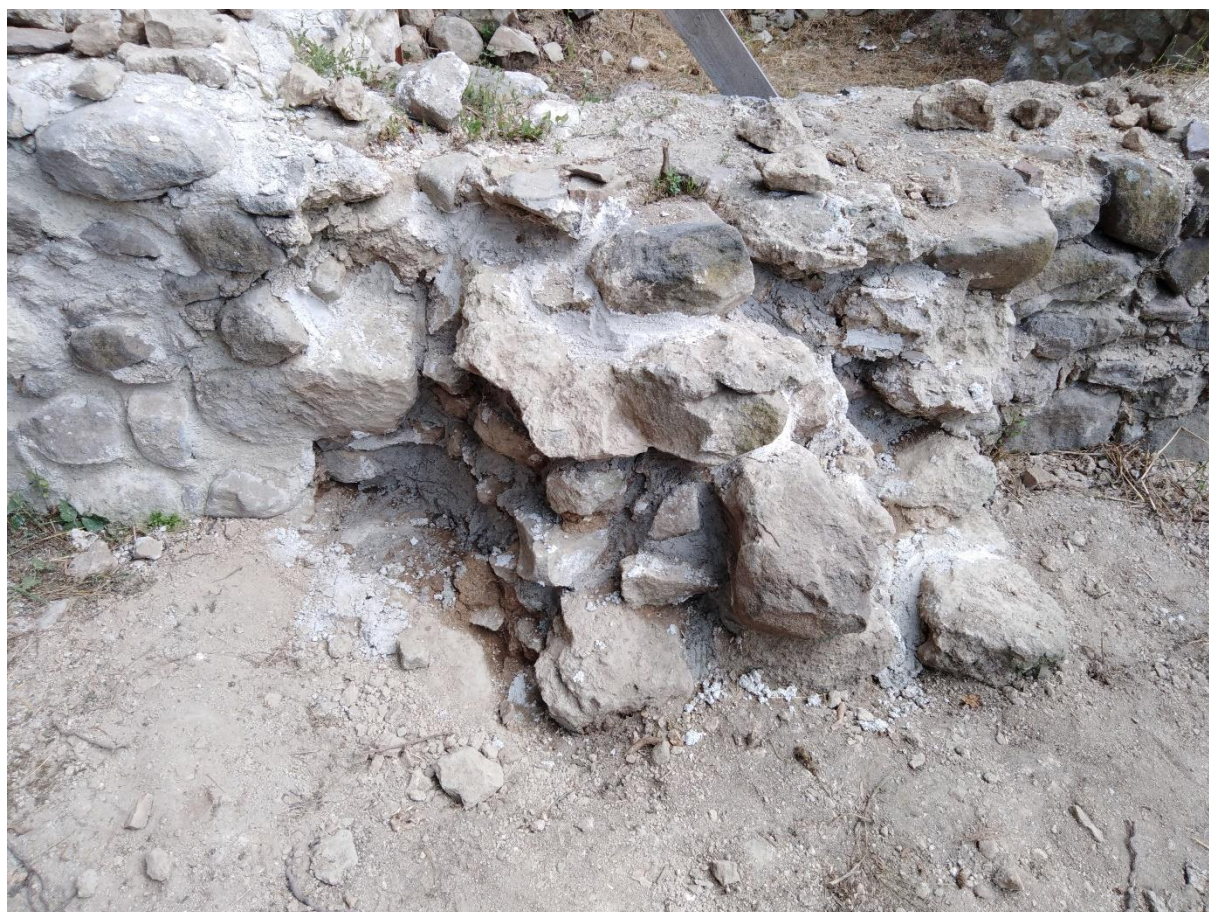
Figure 39 Reconstruction of the Monastery ruin

Technical condition of the site varies. Different parts of the object are in different state, which is caused by different conditions; mainly by a part of the object being covered by roof, which prevents it from the worst element that affects the decay of historical structures – rainwater. Thus it may be

stated that the objects of the fort – bastions or the fortification walls, are in a consolidated condition, and only show local defects, e.g. caverns or holes in the roofing. These defects are slowly remediated. Similar to this, we may assess the object of the chapel and the presentation of the church. The object of the monastery itself was in critical condition. At present, however, an intensive conservation renovation of the object is being carried out, which brings it to a consolidated state.

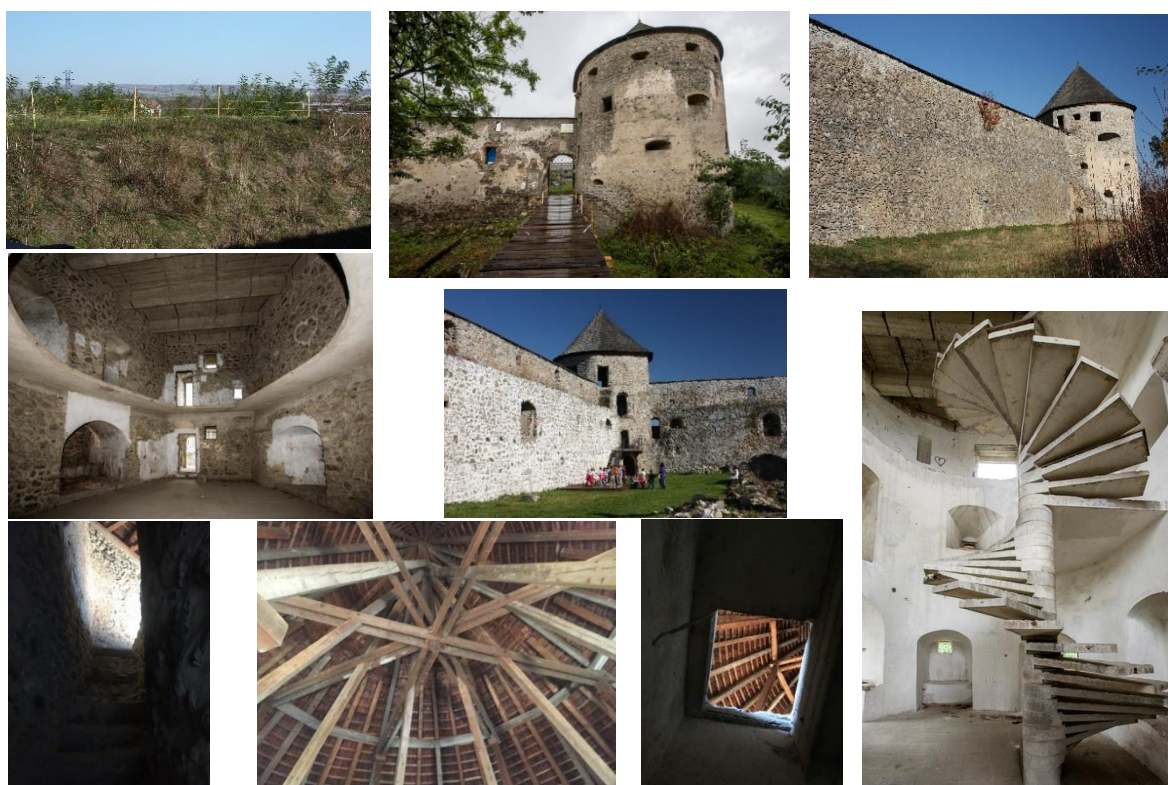
Figure 44 Photo-documentation from the Bzovík castle (visual inspection in December 2017 and July 2018)

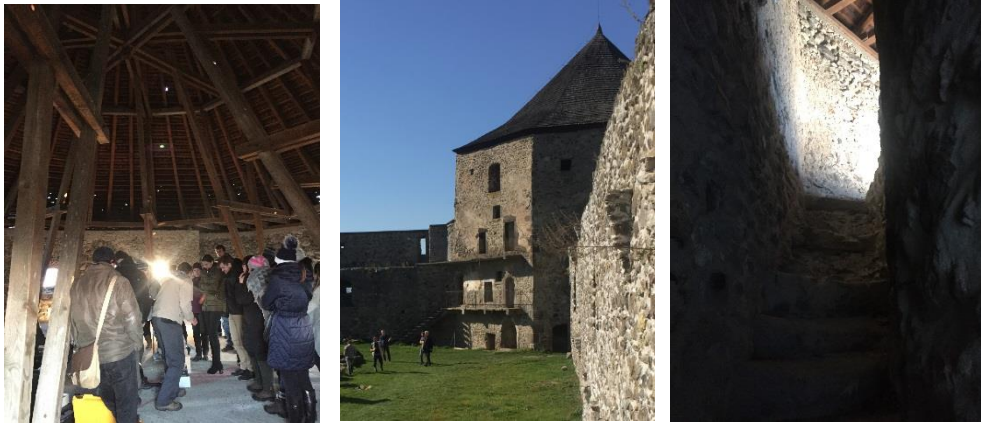
Figure 47 Pictures of the entry tower, where we assume the origin of the fire from the electrical installation

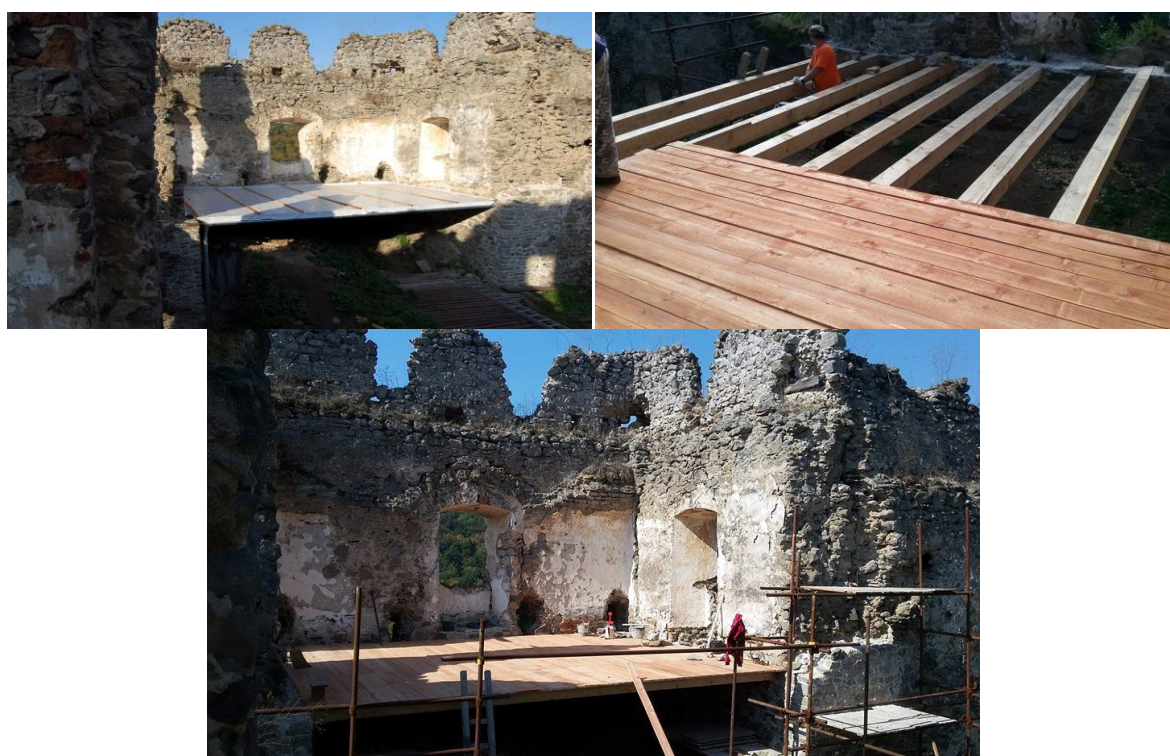
Figure 57 Roof on the defense tower of Castle Čabrad imitating a perished beam ceiling protecting original construction of the vault of the ground floor and redirecting the precipitation waters from the foot of the walls (it was causing a slow sliding of the tower)

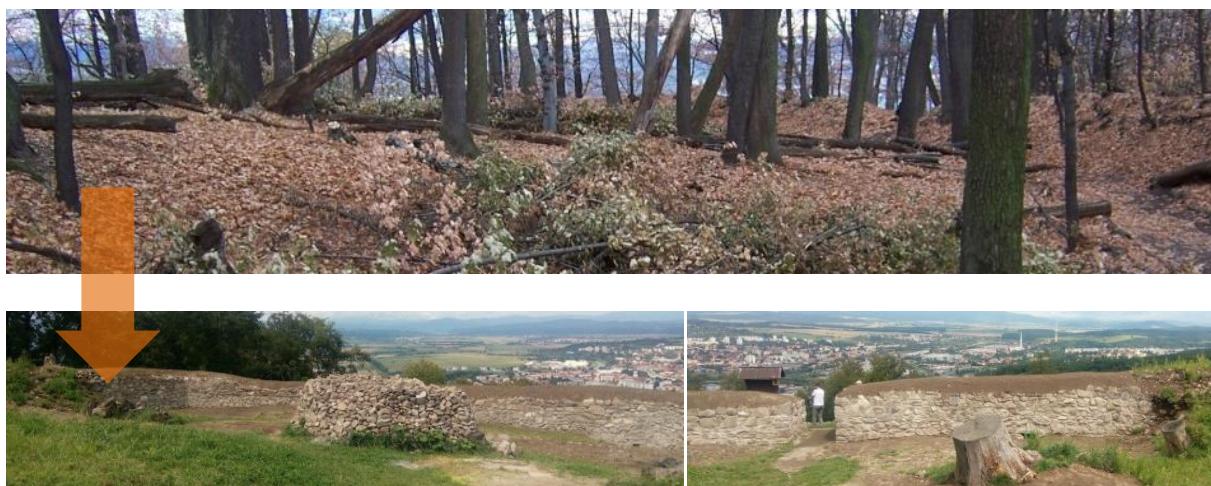
Figure 58 Excavation, conservation and presentation of the lower castle of Castle Pustý Hrad in Zvolen. The ramparts were excavated only in the extent to show the main features of the castle – a section of ramparts, the main tower and the entrance gate. These fea

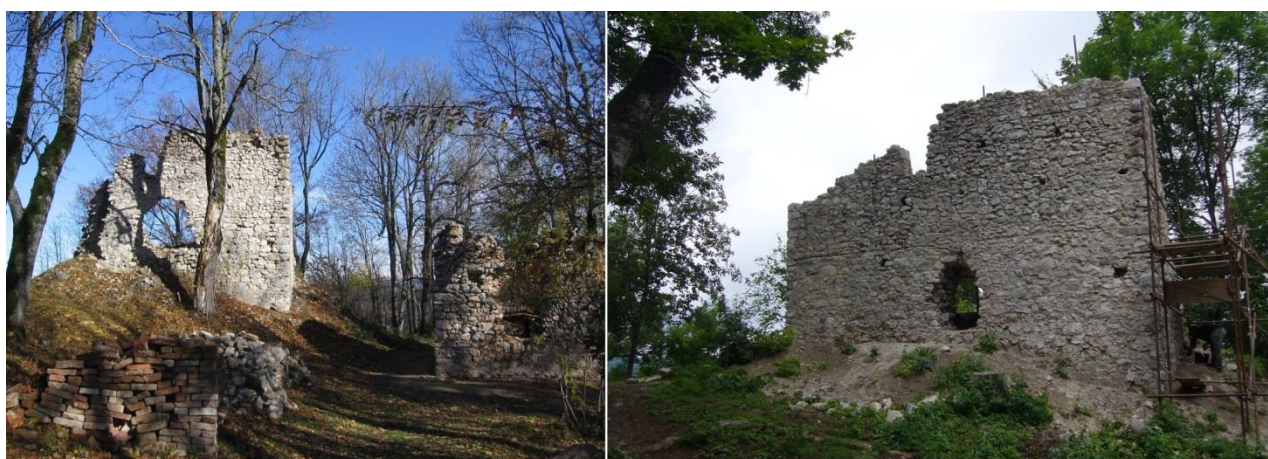
Figure 59 Restoration of the main tower of Castle Muráň which was done without any interference with the buried parts of walls. No details were recreated. The openings in the walls with unknown original shape were left in the form of cavern, only the masonry arou

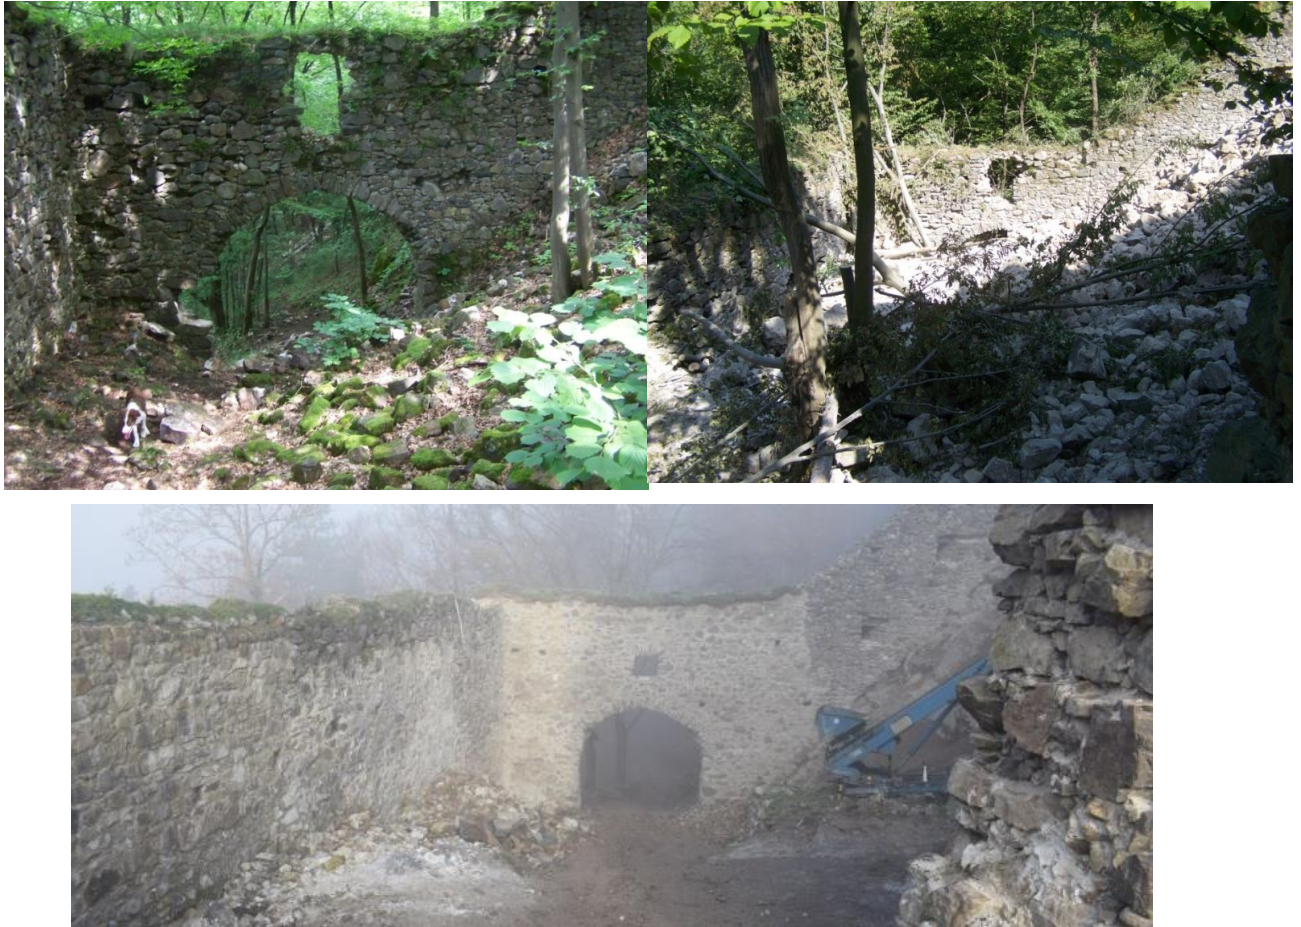
Figure 60 After a large portion of the ramparts of the inner part of the castle collapsed and filled the outer courtyard with rubble, it made the entrance gate impassable. Since there was no other access, the cleanup of the rubble had to be performed by hand, whi

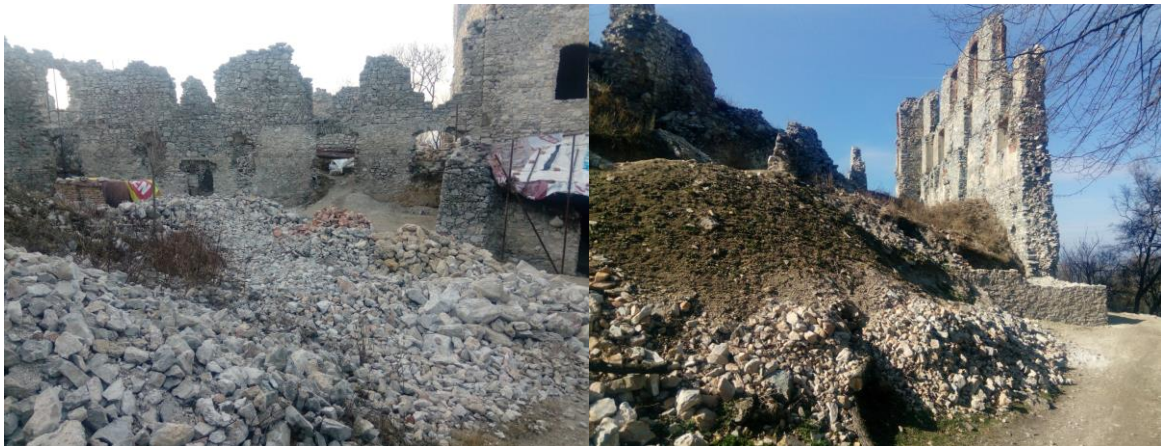
Figure 62 The abundance of manpower due to the program is sometimes difficult to manage in keeping everyone occupied. The solution of the coordinators is often to occupy the workers with digging the rubble which produces lots of historic building material. To sto

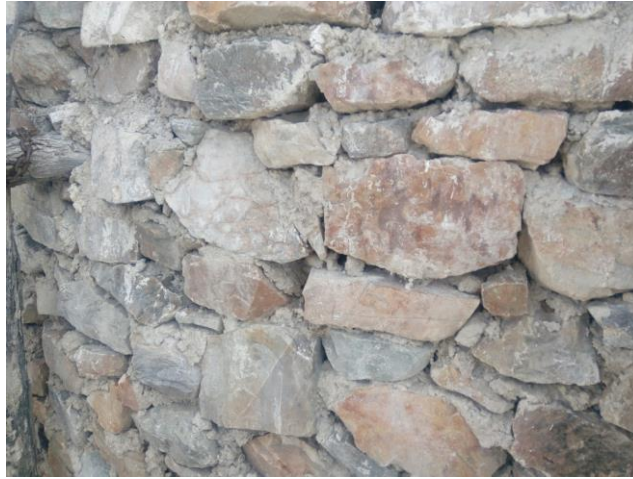
Figure 63 As the workers employed by the project are rarely professionals, they have no experience in the work they are hired for. This can undermine the professional work, and result in poorly executed craftsmanship. An example is this piece of masonry with no e

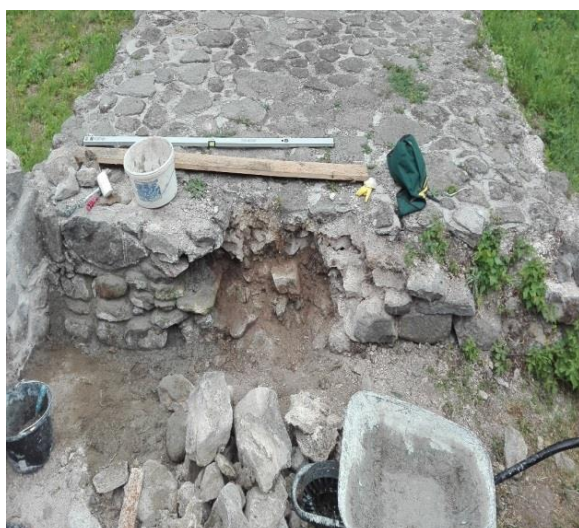
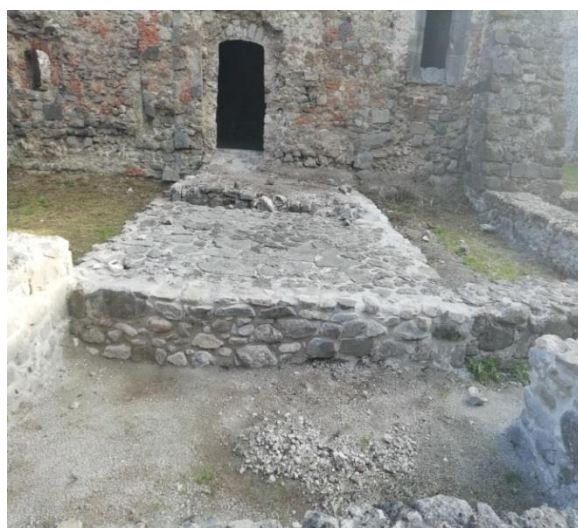
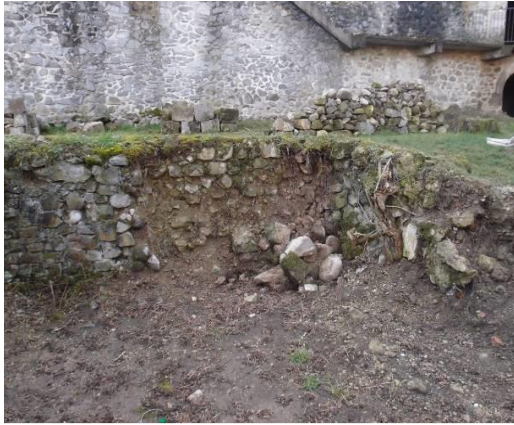
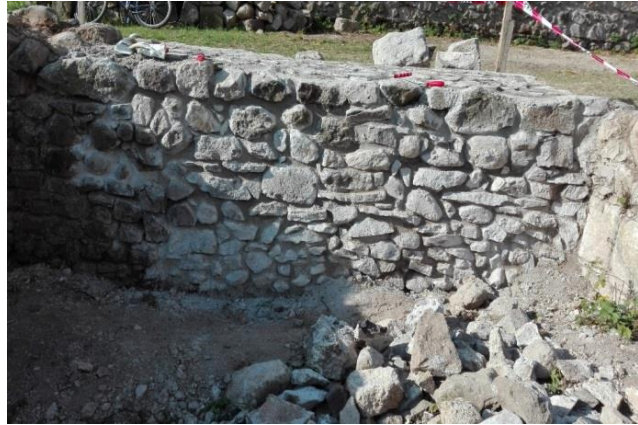
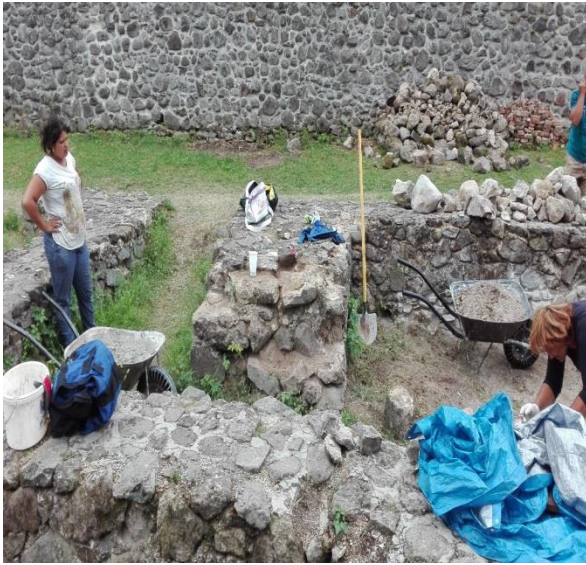
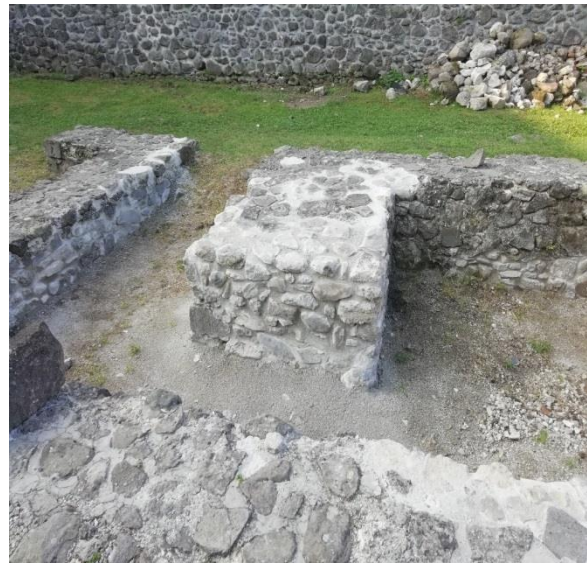
Examples “Conservation of the Castles by the Unemployed” from Bzovík

The two examples from Bzovík show the decomposed restoration from 1960s. Bzovík is only starting with the restoration. It is the first time the program is applied here, which is why this part was selected for the new employees to learn the craftsmanship. The result could be assessed as average, as the gaps between the stones are kept rather narrow and the strive for bond between the stones may be seen here, but the structure of the masonry is not of the best quality with the small stones concentrated in the lower part, and the big flat stones in the upper part. The structure is easily recognizable from the original.

For the first time in 2018, Bzovík took part in the project 'Conservation of Castles by the Unemployed'. The program brought in the first real jobs connected with the ruin. The municipality employed 15 people for seasonal construction jobs for the season spring-fall, while only one person was replaced on his own will. The project paid wages in the sum of 72.34% of the average wage in the country for unprofessional workers and 54.18% of the average salary in the country for professional workers. If the municipality eventually succeeds in acquiring funding through this program in following years, almost all of the workers are allowed to return to their position.
